## Section Two Functional Needs Assessments

# Functional Needs Assessment

# Section Three Facility Condition Assessments

# Facility Condition Assessments

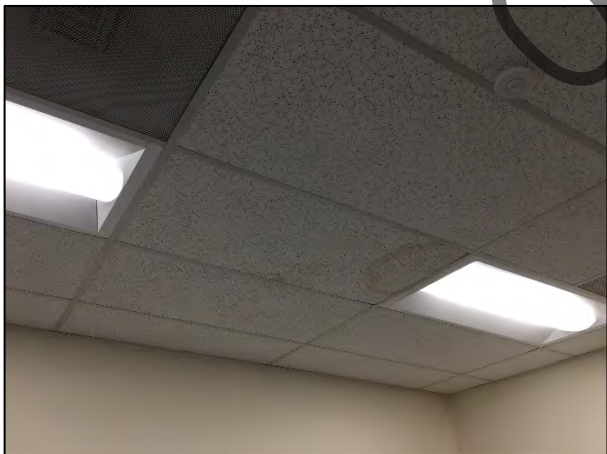
Water stained ceiling tiles

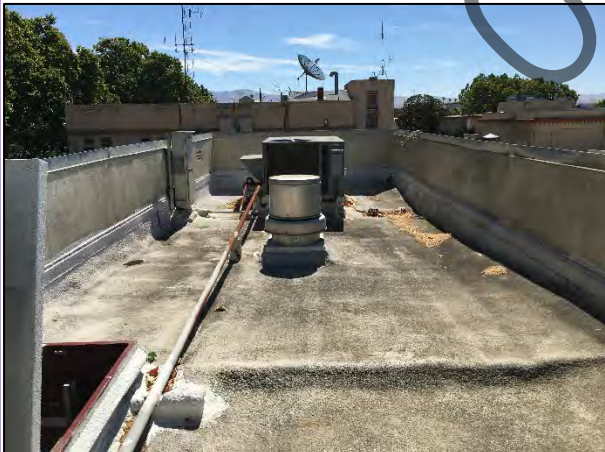
Failing Low Slope Roof

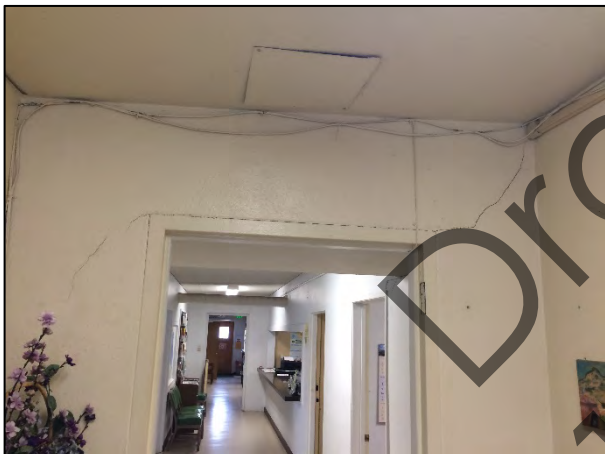
Hallway with exposed wires and wall cracks

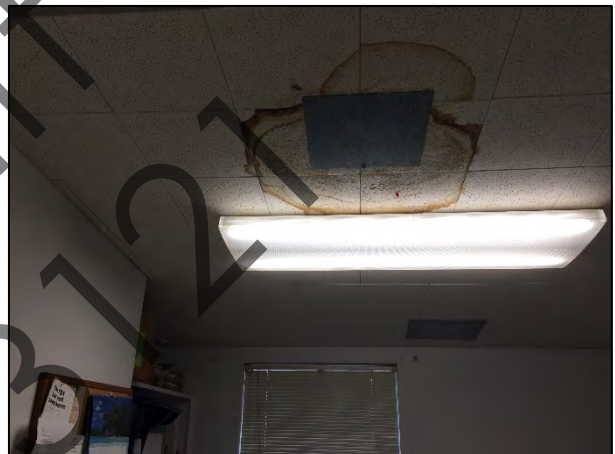
Stained ceiling tiles from roof leaks

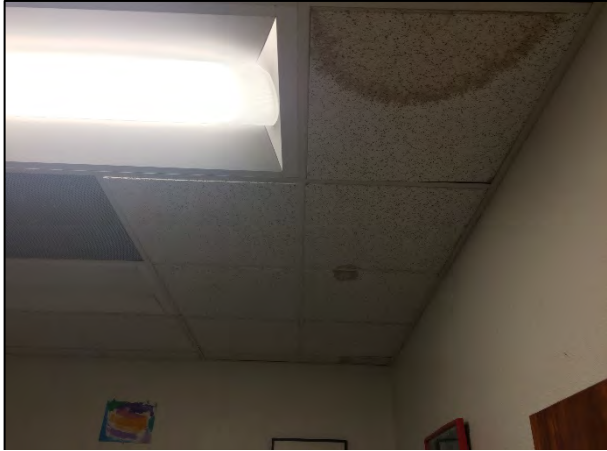
Stained ceiling tiles

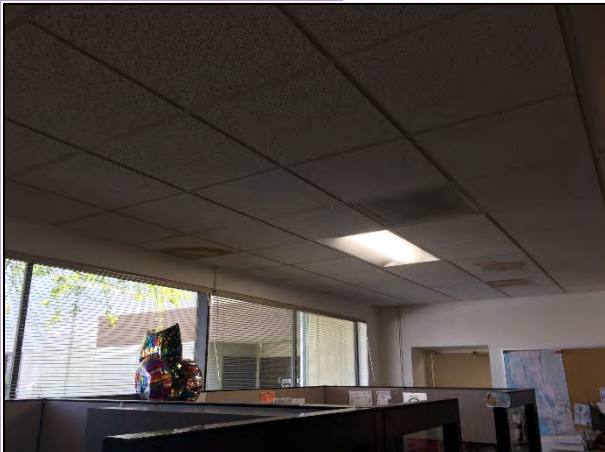
Stained ceiling tiles in office area

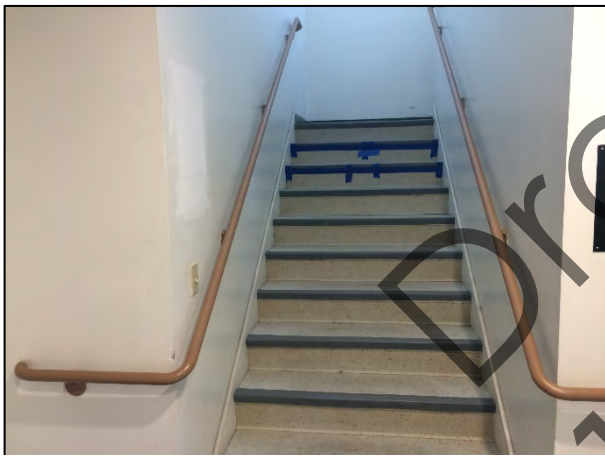
Stair needing nosing repaired

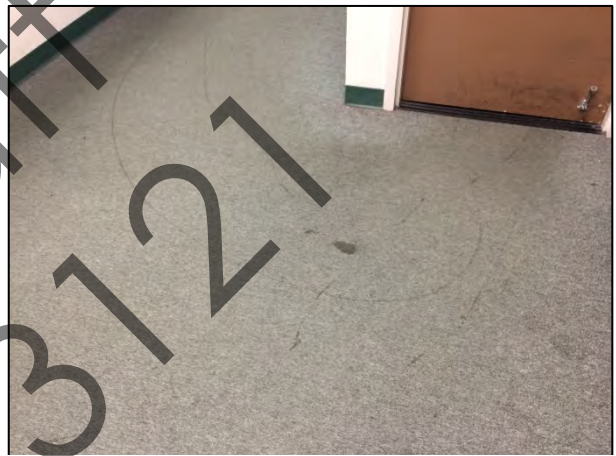
Badly stained and worn carpet

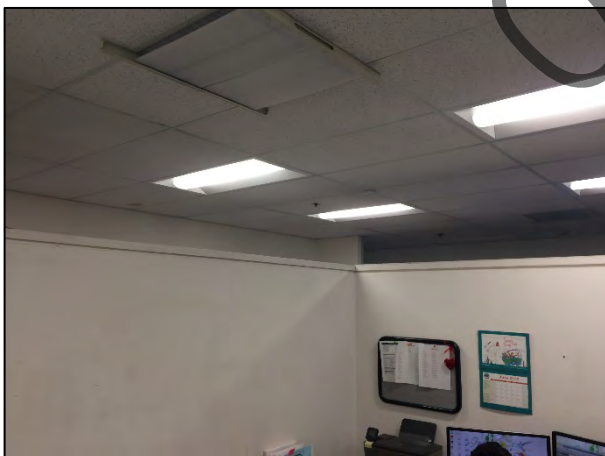
Office area with HVAC grille covered

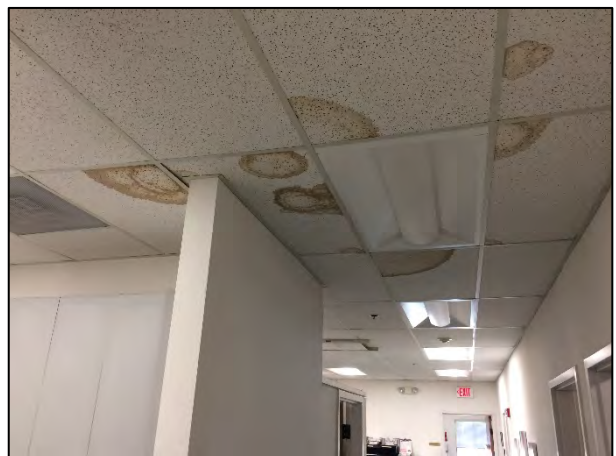
Stained ceiling tiles

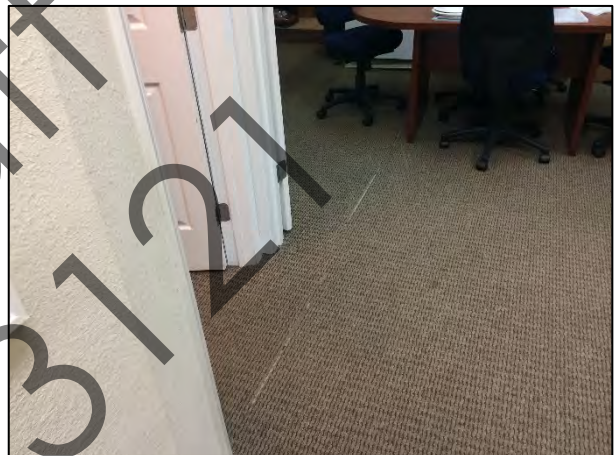
Damaged carpet

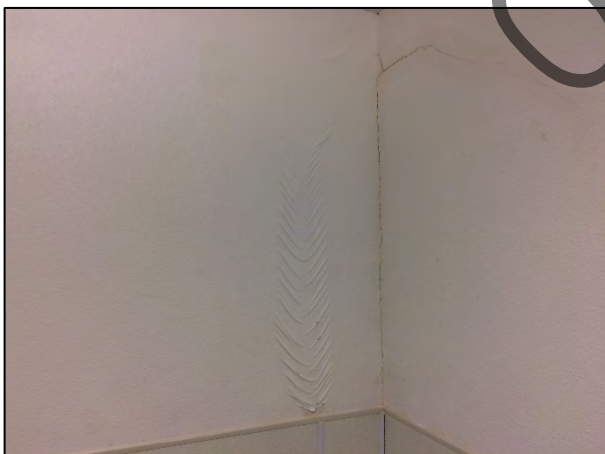
Water damage in restroom

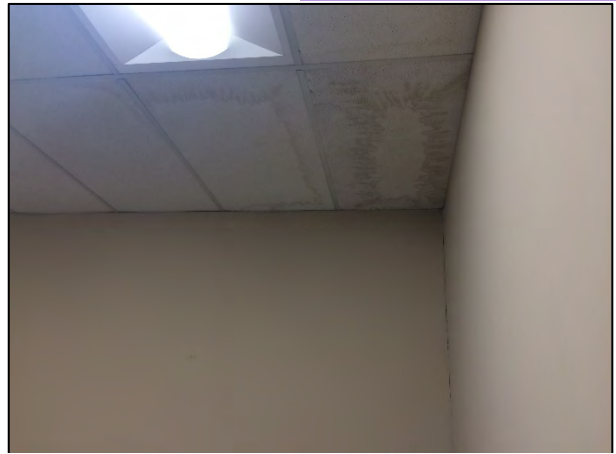
Stained ceiling tiles

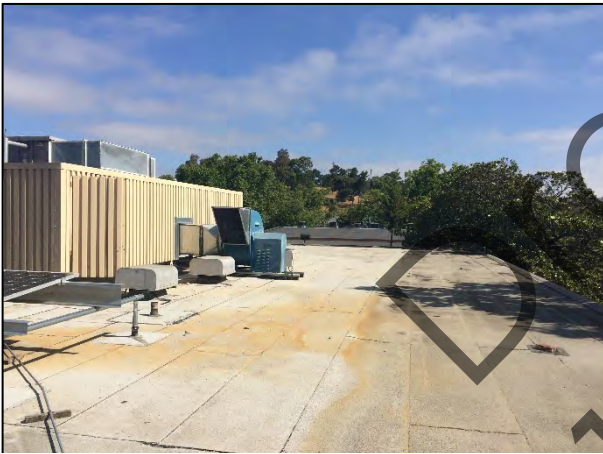
Roof with stains from standing water

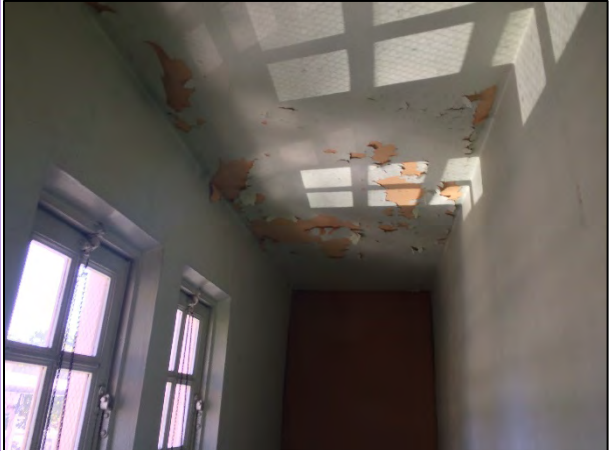
Peeling paint at ceiling

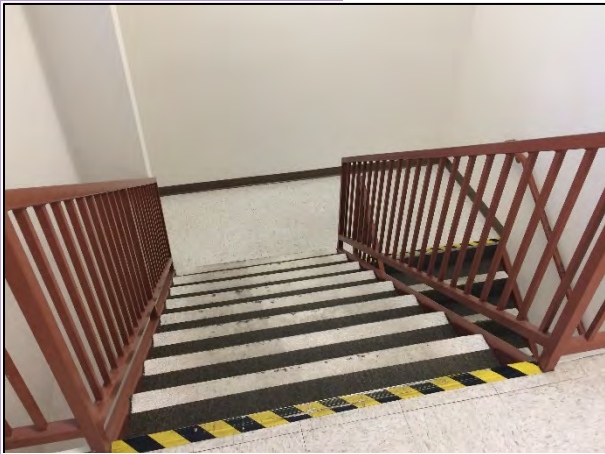
Stair with non-compliant handrail

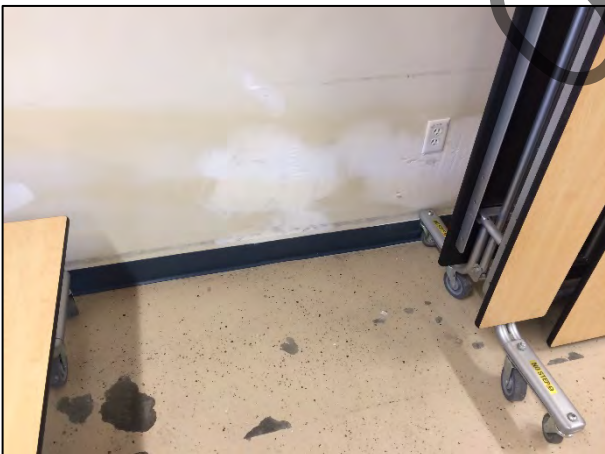
Wall and floor damage

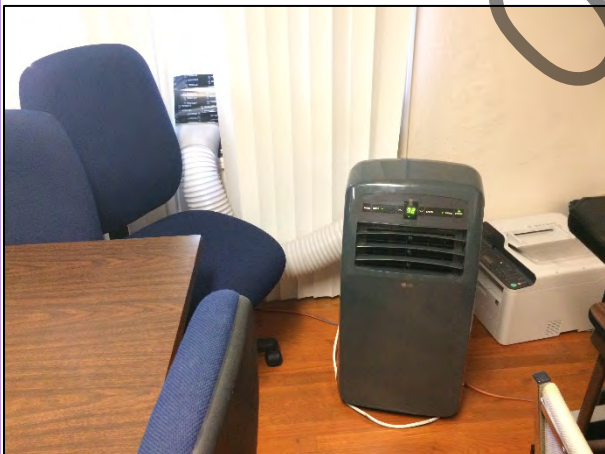
Portable air conditioner

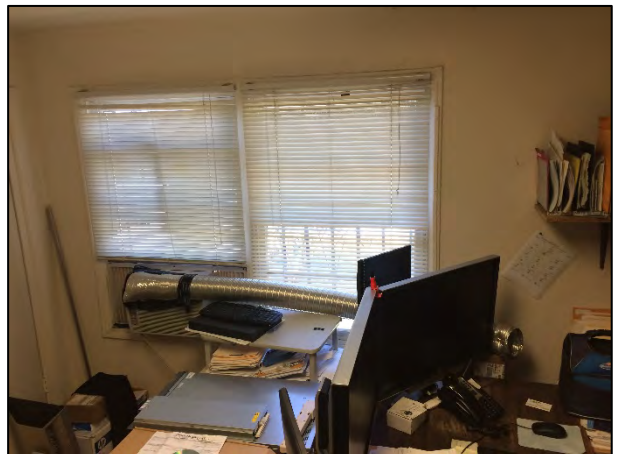
Office with window air conditioner and duct

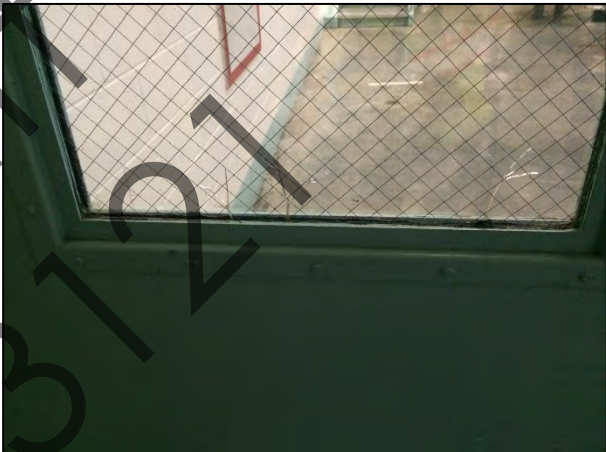
Cracks in security glazing

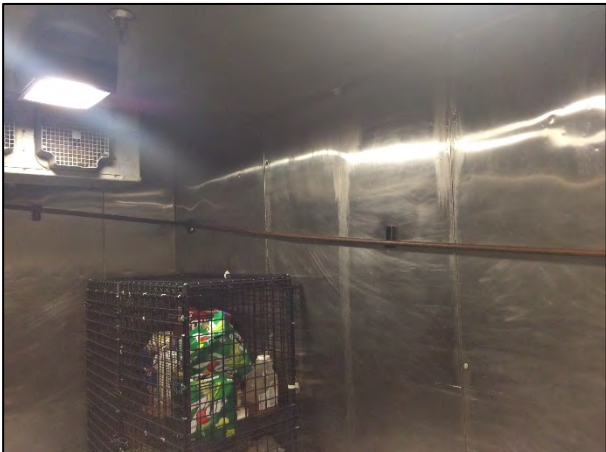
Walk-in Box panels rusting from condensation

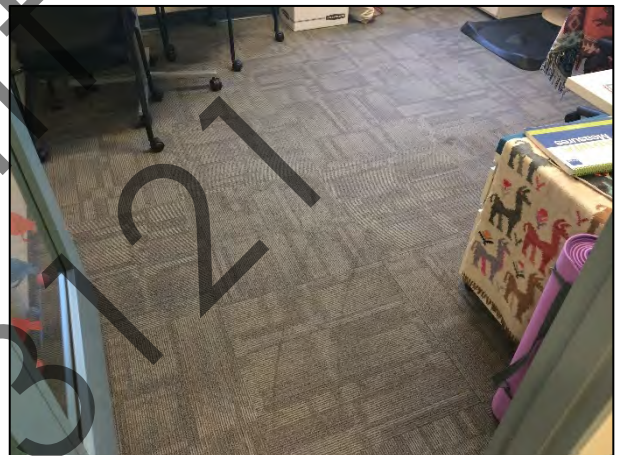
Stained/damaged carpet

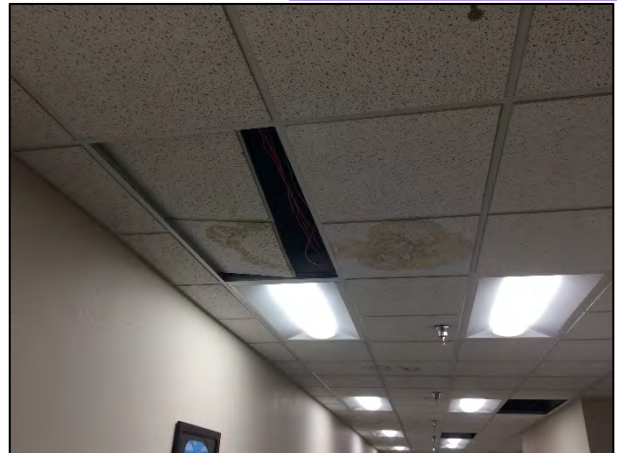
Stained ceiling tiles

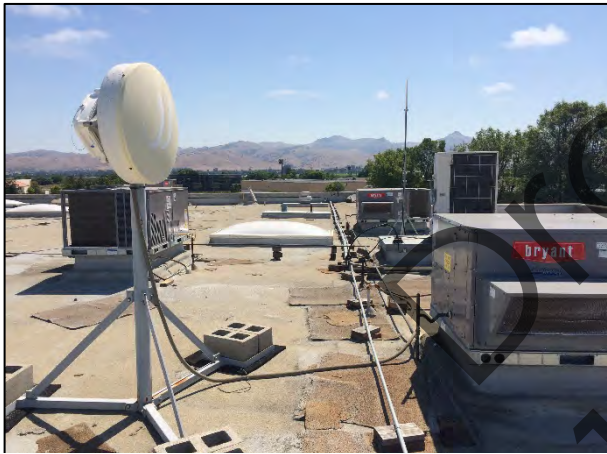
New equipment, old roof

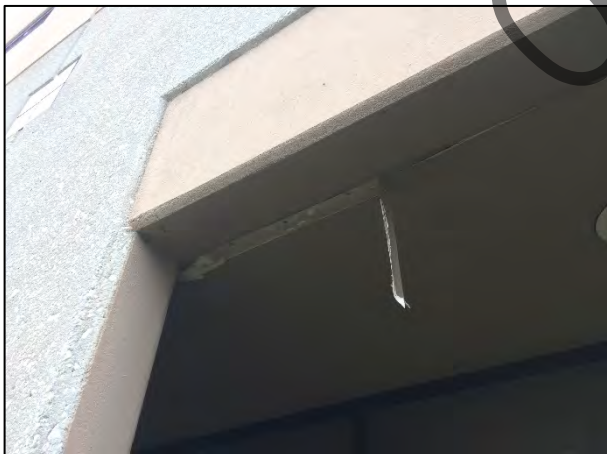
Failed GWB soffit
