GEOTECHNICAL INVESTIGATION OF THE TRES PINOS FAULT

COMBINED GEOTECHNICAL AND FAULT INVESTIGATION
FAIRVIEW ROAD PROPERTY
FAIRVIEW ROAD
SAN BENITO COUNTY, CALIFORNIA

PROJECT 8250

November 1989

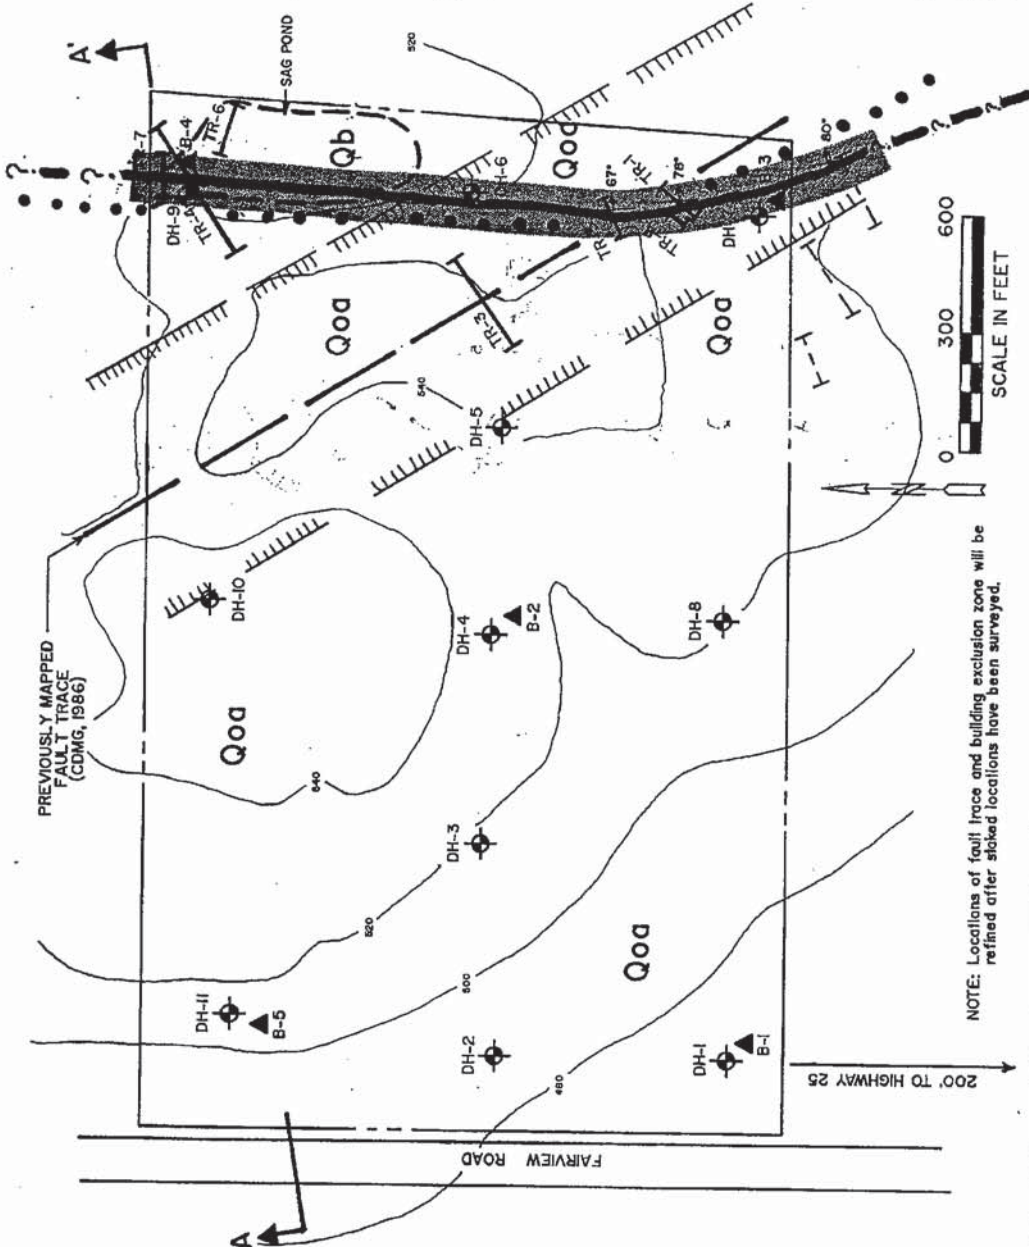
Evidence of faulting was observed in Trenches 1, 5 and 7; slickensided, polished clay surfaces and displaced and terminated bedding were observed in older alluvial deposits along the photolineament in the eastern portion of the property (see Figures 2, 4, 8, and 9).

We recommend a 50-foot-wide building setback on each side of the fault zone, which results in a building exclusion zone 118 to 140 feet wide. The location of the fault encountered in our trenches has been staked in the field for surveying by Ruth and Going, Inc. Ruth and Going, Inc. will prepare a map showing the surveyed locations of the fault trace and exploration trenches.

NOTE: Locations of fault trace and building exclusion zone will be refined after staked locations have been surveyed.
