## **Final Report**

# Quantifying the Impact of Out-of-County Waste Transport on San Benito County

Economic & Planning Systems, Inc.  
Pavement Engineering Inc.  
TJKM

December 29, 2017

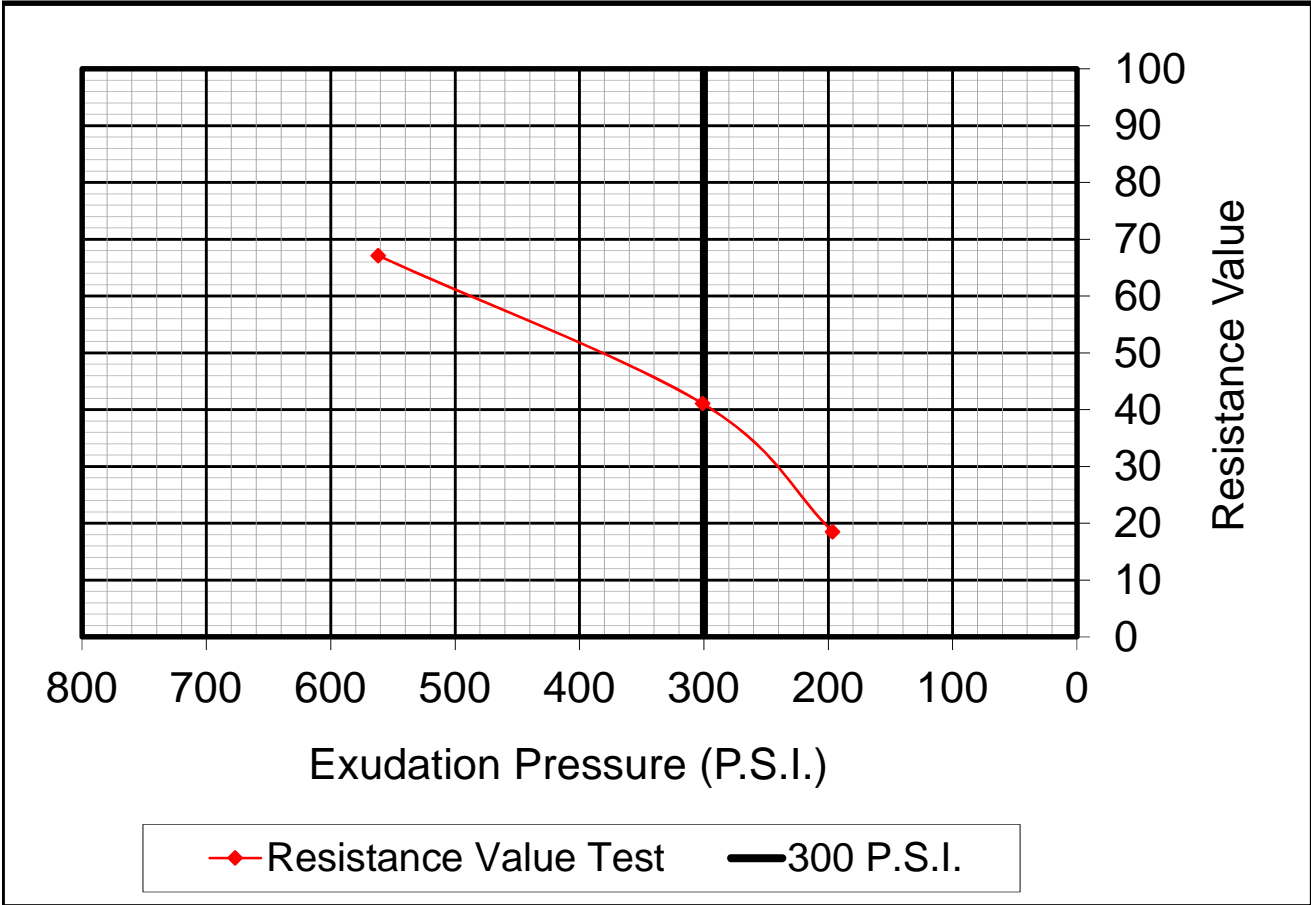
Specimen No.	1	2	3
Moisture Content (%)	8.1	9.2	9.7
Dry Density (PCF)	136.2	135.4	134.1
Resistance Value (R)	67	41	19
Exudation Pressure (PSI)	562	301	196
Expansion Pressure	0	0	0
As Received Moisture Content (%)	8.1

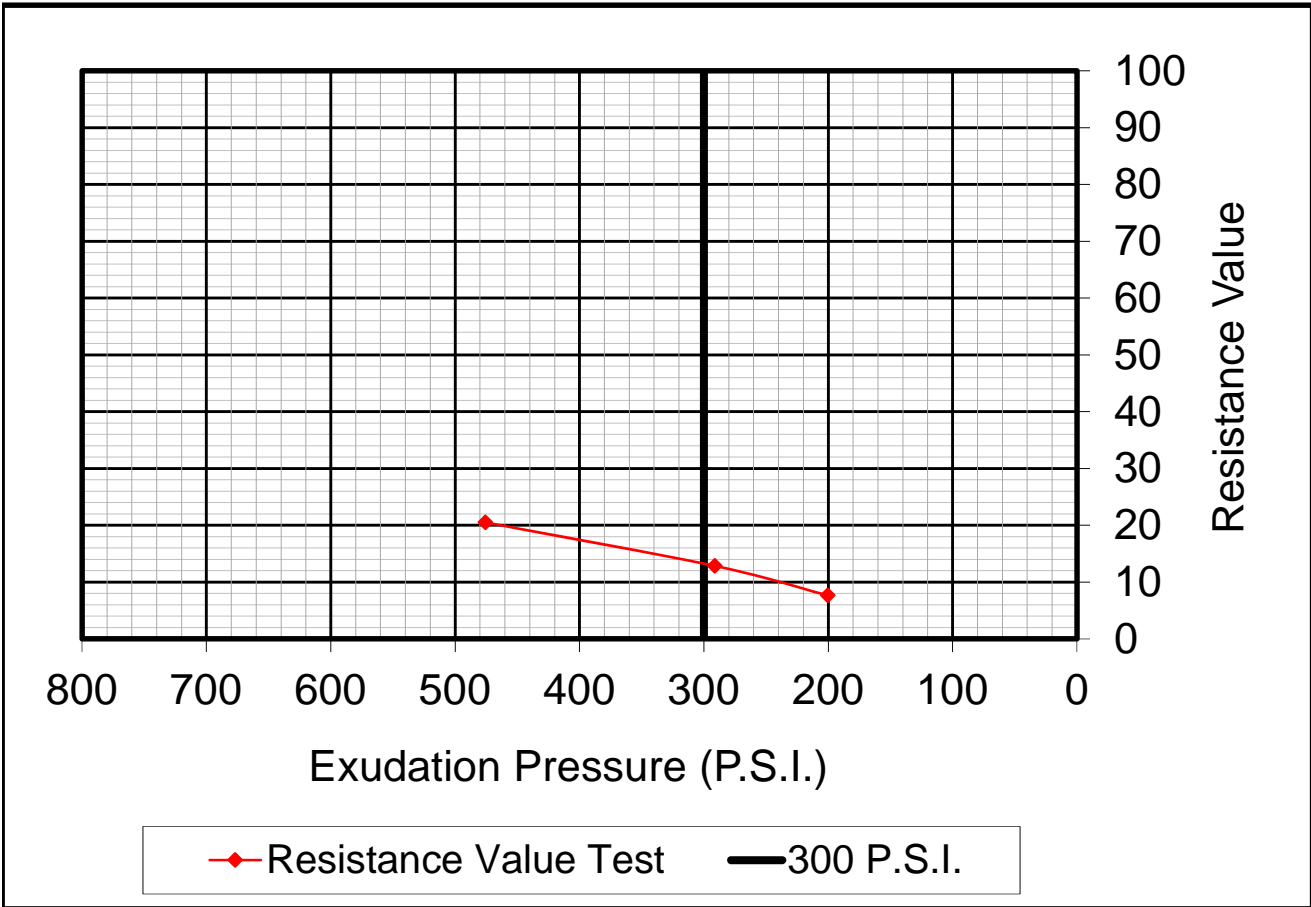
Specimen No.	1	2	3
Moisture Content (%)	9.7	10.8	11.4
Dry Density (PCF)	130.6	129.2	128.1
Resistance Value (R)	21	13	8
Exudation Pressure (PSI)	476	291	200
Expansion Pressure	65	35	17
As Received Moisture Content (%)	9.7

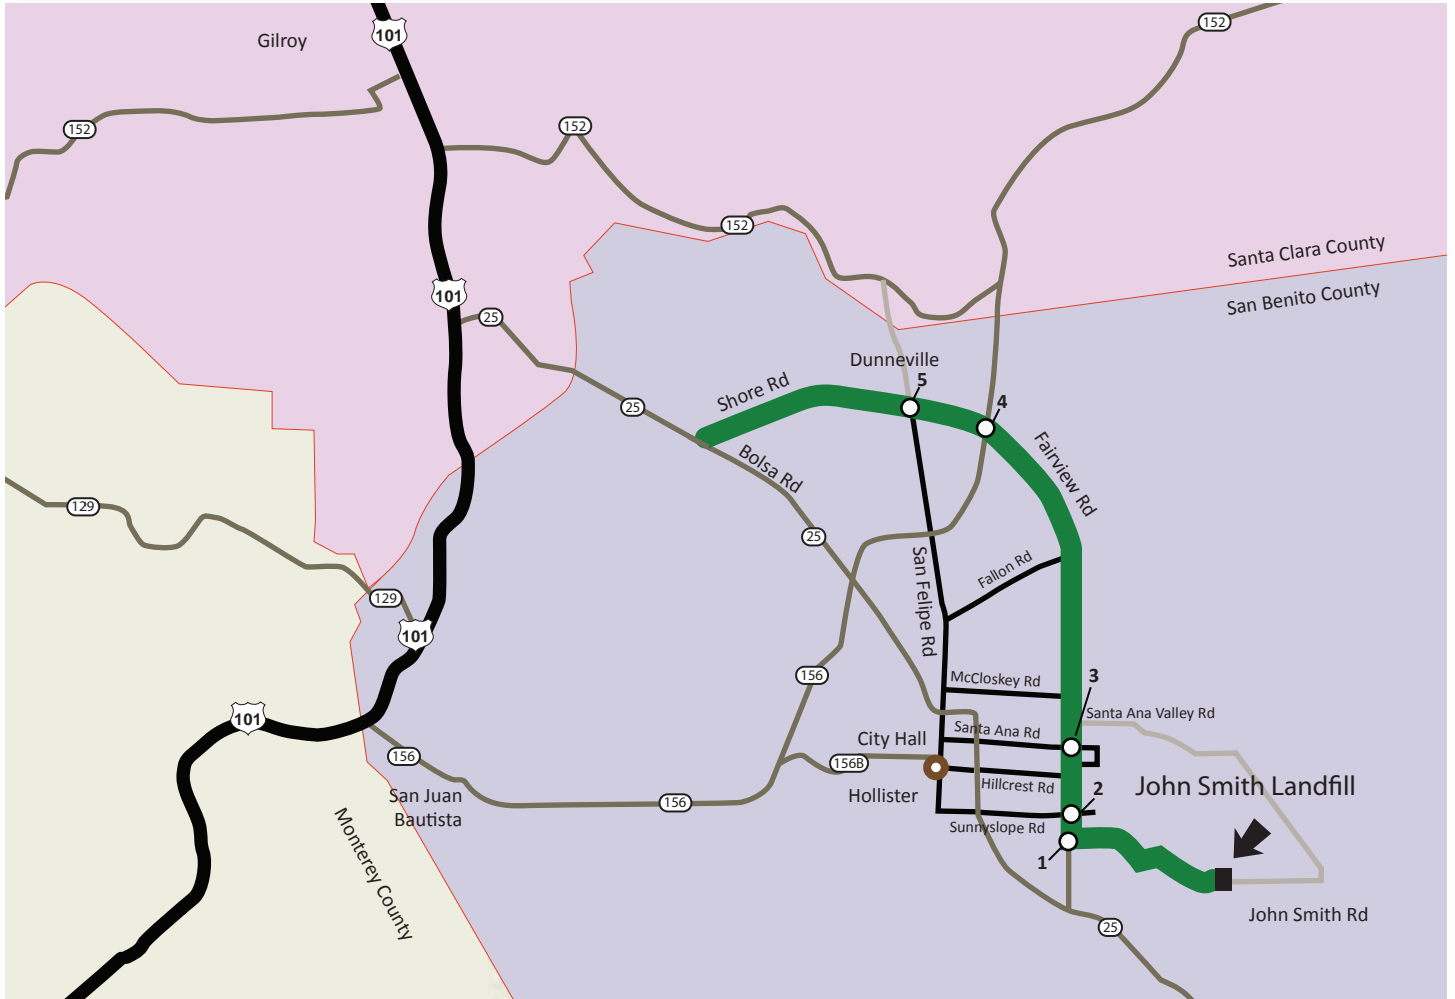
# Existing Conditions Traffic Volumes, Lane Geometry & Traffic Controls

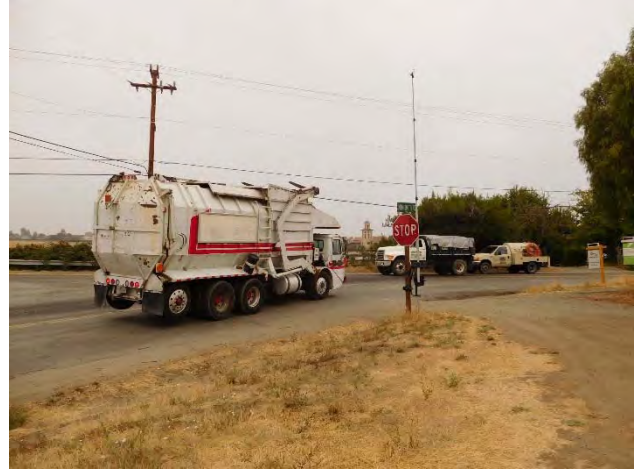
*Intersection of Fairview Road and John Smith Road*

At the intersection of Fairview Road and John Smith Road, the roadway is narrow and there is no left turn pocket eastbound onto John Smith Road. Trucks turning onto John Smith Road created a small queue of vehicles as the truck waited for the opportunity to turn left. The three-legged intersection is narrow along Fairview Road. John Smith Road, at this intersection, is wide and angled towards northbound Fairview Road. From existing data collected, the majority of the movement from John Smith Road is the northbound right turn. Along Fairview, the through movement is predominant with the northbound volumes higher in the a.m. peak hour and southbound volumes higher in the p.m. peak hour.

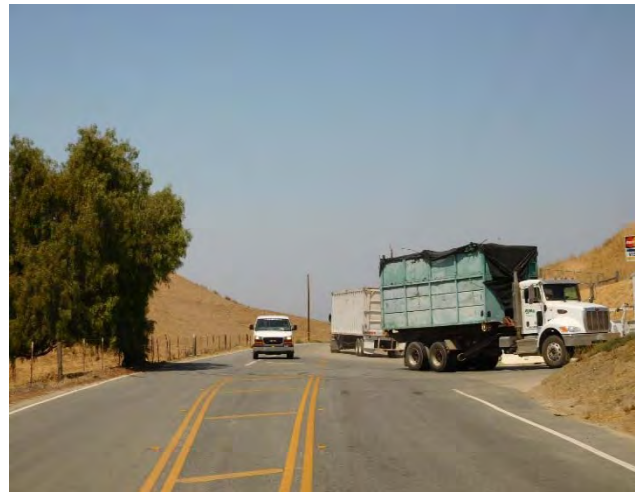
*John Smith Road Landfill Entrance*

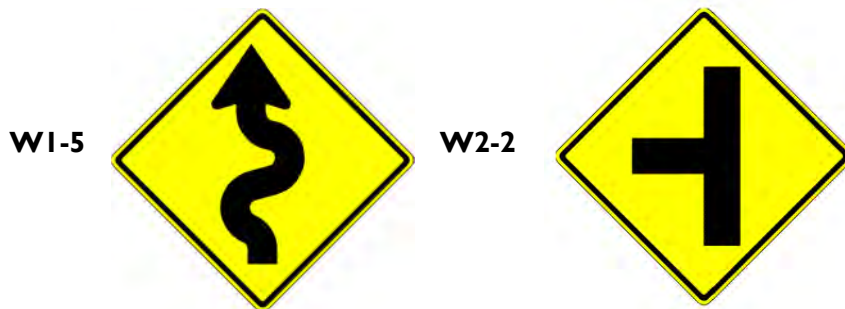
Additional suggested recommendations would be to include sign additions along John Smith Road such as a speed limit signage, R2-1 (55 mph), and warning signs such as the W1-5 for winding road and W2-2 for side road to alert the driver of the roadway conditions. Advanced warning signage of the John Smith Road Landfill is also recommended.

Speed limit signs are recommended at the eastbound entrance to John Smith Road from Fairview Road, and westbound near the exit of the landfill on John Smith Road. Two winding road signs, located eastbound, east of Heatherwood Drive on John Smith Road and west of the John Smith Landfill in the westbound direction are recommended. Two side road signs, W2-2 are recommended in the eastbound direction towards the landfill at approximately 1,000 and 300 feet in advance of the landfill entrance. Sign locations are based on the standards set forth in the California Manual on Uniform Traffic Control Devices (CAMUTCD). Signs and posts cost approximately \$500.00, for a total cost of \$3,000.00. The consideration of advance flashing warning lights located 300 feet west of the landfill (at the same location as the second W2-2 sign) would allow for visibility during fog or other adverse weather conditions. The approximate cost of the installation and equipment for a flashing warning sign is \$25,000 considering the limited power source along the rural roadway.

TJKM recommends signage, including a speed limit sign, and advanced warning signs, would contribute to safer travel along the rural roadway on John Smith Road to the landfill.
