Project Name: Panoche Road Bridge Replacement

*Panoche Road Bridge (43C-0070) Replacement
at Tres Pinos Creek
05-SBi-0-CR
Federal Project No. BRLS-5943 (056)
Regional Location*

*Panoche Road Bridge (43C-0027) Replacement at Tres Pinos Creek
Federal Project No. BRLO-5943(056)
Representative Photos of Tres Pinos Creek*

Panoche Road Bridge (No. 43C0027) Replacement at Tres Pinos Creek

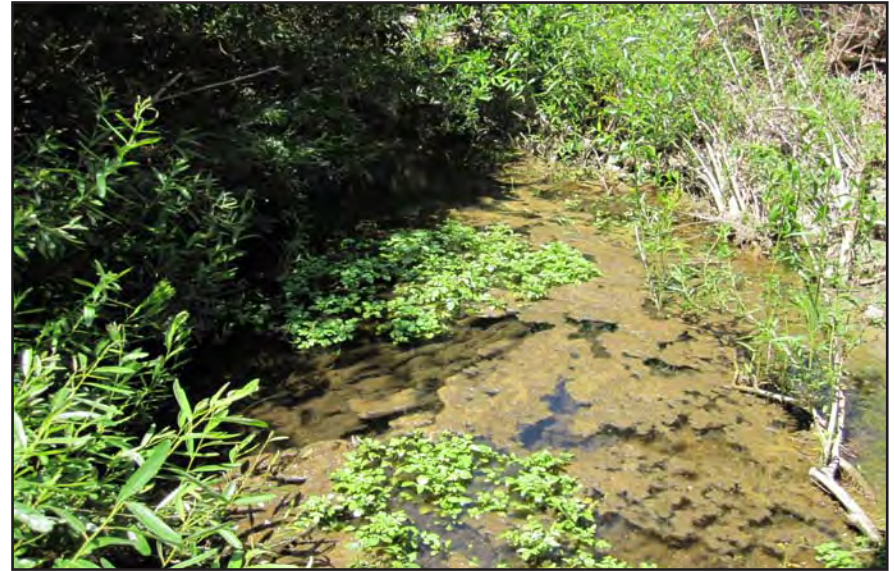
Tres Pinos Creek directly under bridge. Frogs observed at this location.

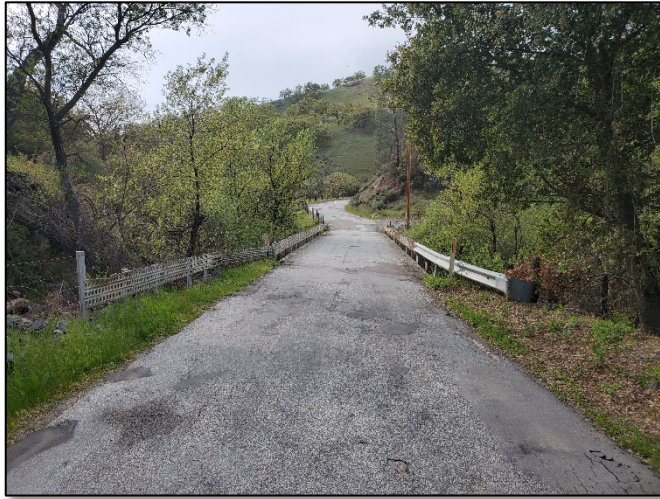
Existing Panoche Road Bridge looking northwest. 'S' curve in roadway would be eliminated.

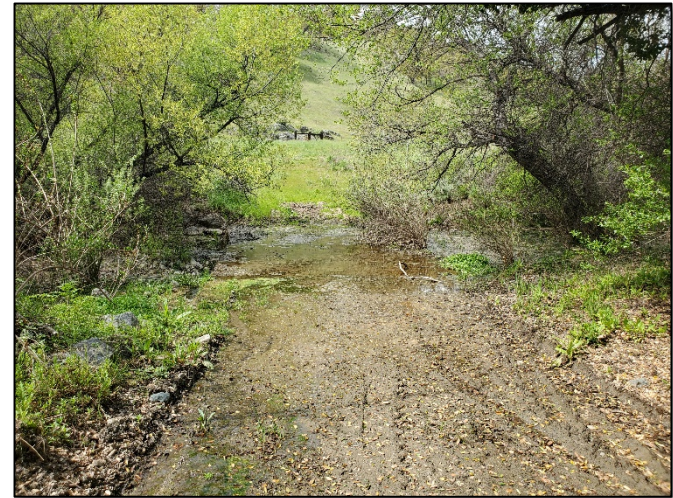
Low water crossing north of existing bridge, looking northwest.

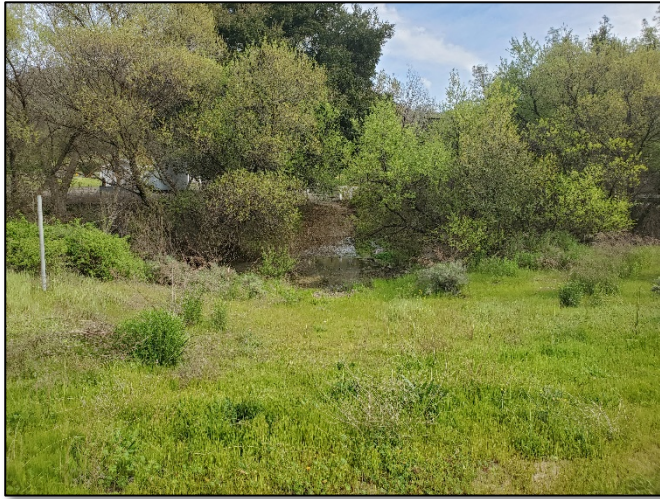
Low water crossing north of existing bridge, looking southeast.

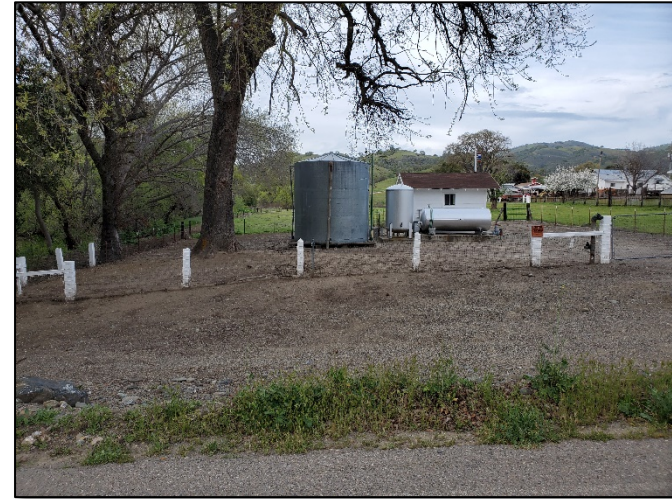
Spring box and pump house north of Panoche Road, east of Tres Pinos Creek, looking northeast.
