## Section Two Functional Needs Assessments

# Functional Needs Assessment

# Section Three Facility Condition Assessments

# Facility Condition Assessments

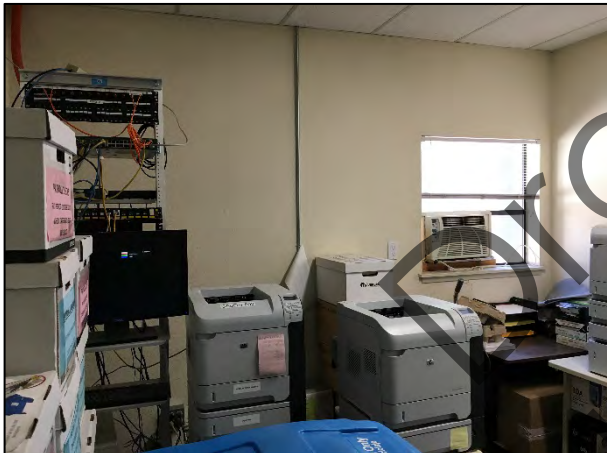
Server Room with Window A/C

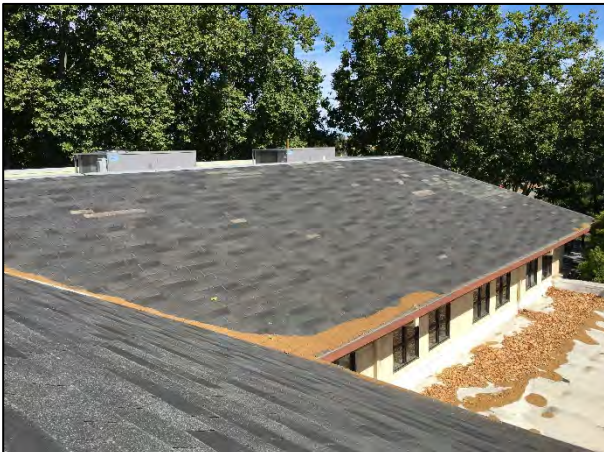
Failing Asphalt Shingle Roof

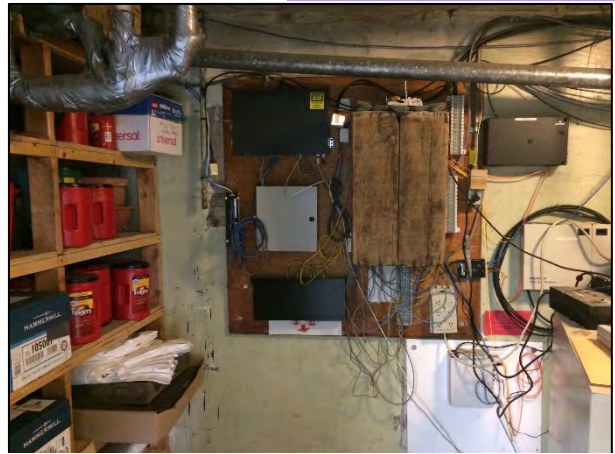
Utility Room, note wood box over equipment to prevent vermin chewing wires

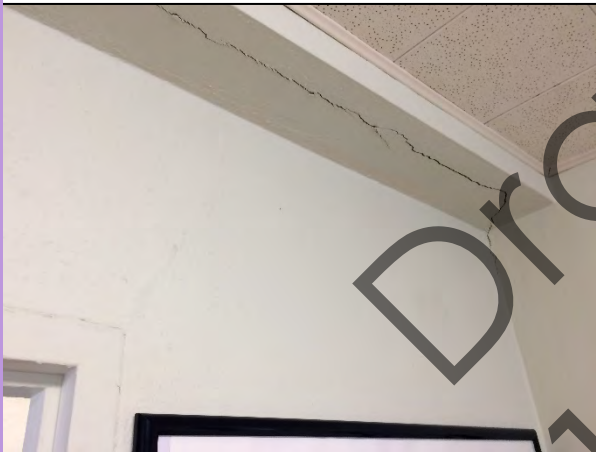
Cracking at wall/ceiling

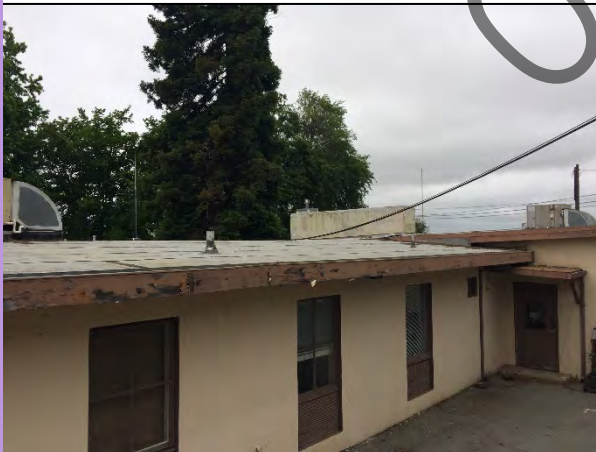
Failing Low Slope Roof

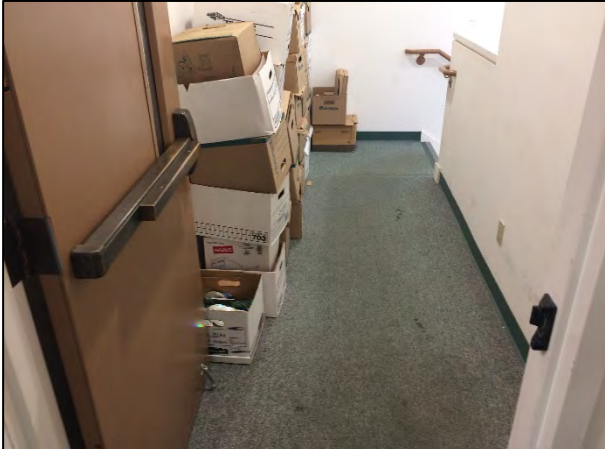
Boxes stored in exit stair

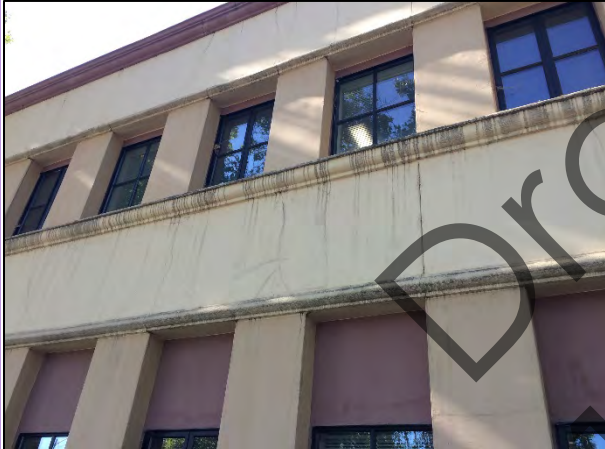
1. Substructure/Structure	Investigate potential settlement issues	\$ 80,909
2. Exterior Envelope	Extensive repair/replacement of exterior walls and	\$ 315,798

Stucco badly stained and cracked

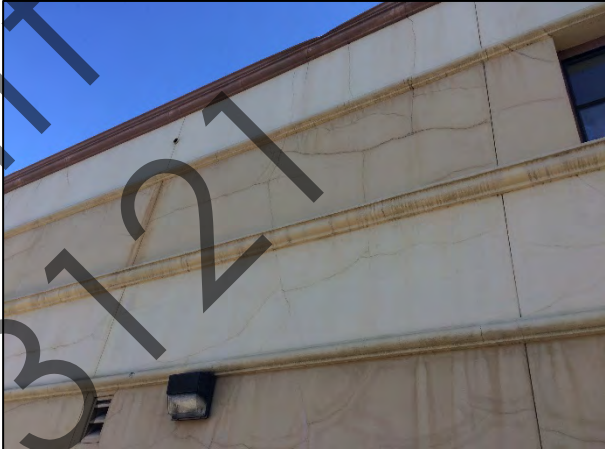
Stucco badly stained and cracked

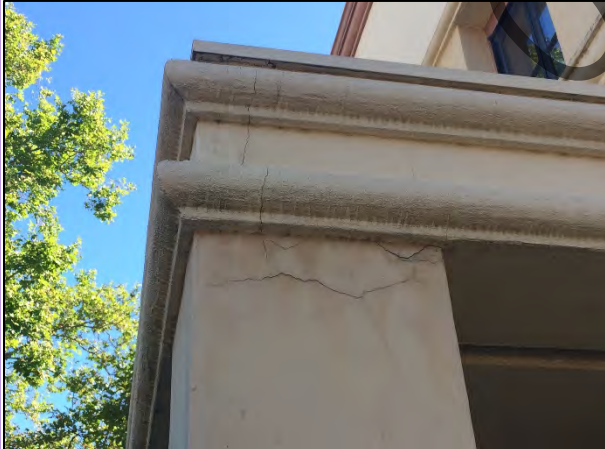
Stucco badly stained and cracked

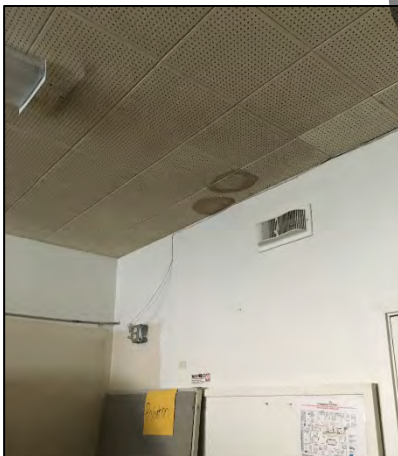
**Facility Summary Observations:** The Former Public Health Building is located in downtown Hollister on the same block as other County government facilities. The facility is in very poor condition and should be removed.

Interior water damage

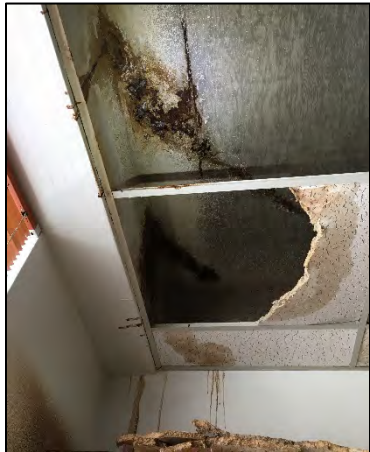
Water damage in structure

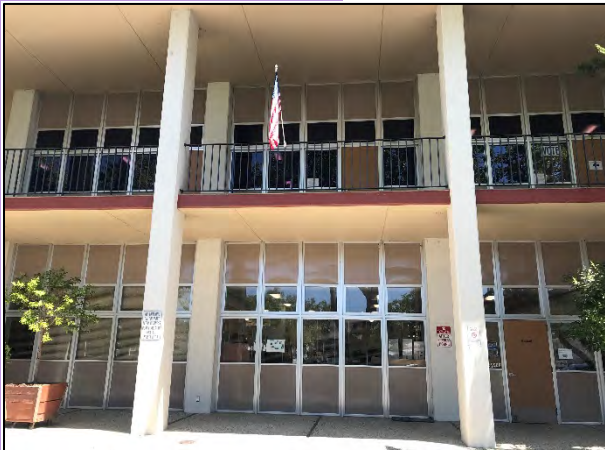
Exterior showing uninsulated curtainwall

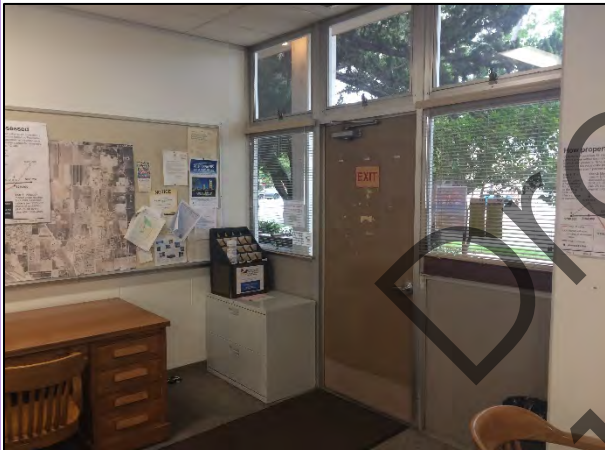
Outdated exterior wall system

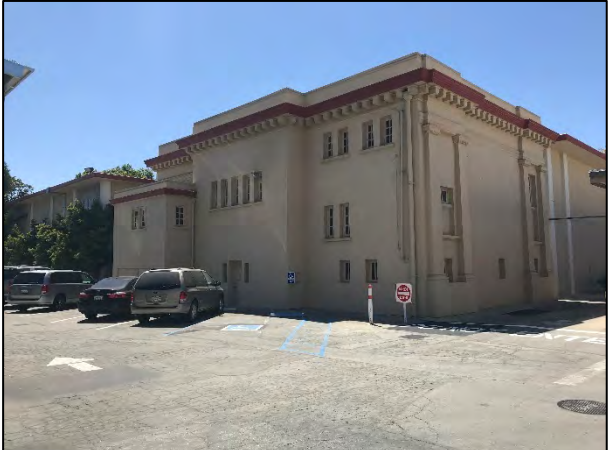
Exterior of Old Hall of Records

The Old Hall of Records is in extremely poor condition, beyond its useful life and can likely never be brought up to modern day standards for use. The Old HOR should be replaced.

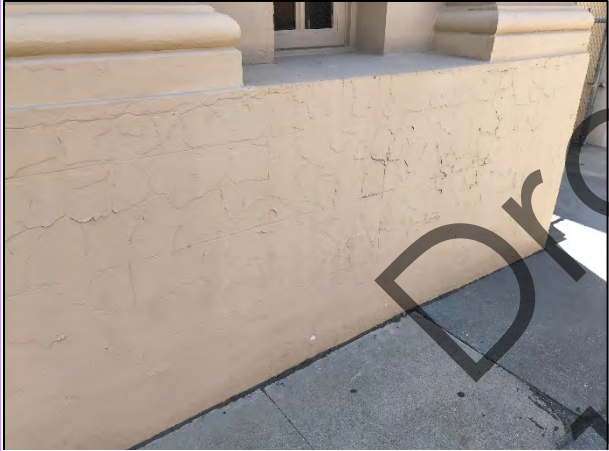
Peeling paint and stucco/plaster

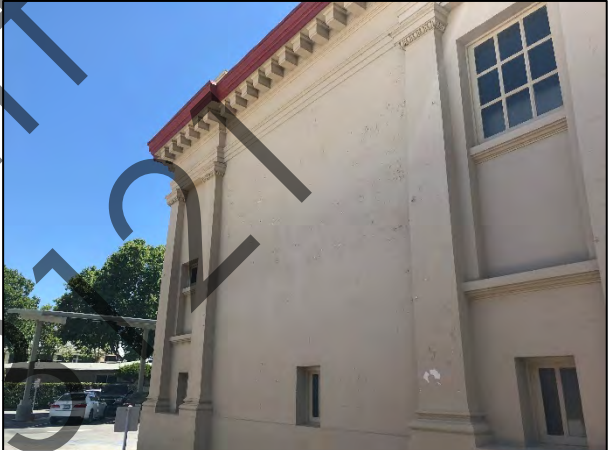
Peeling paint and stucco/plaster throughout

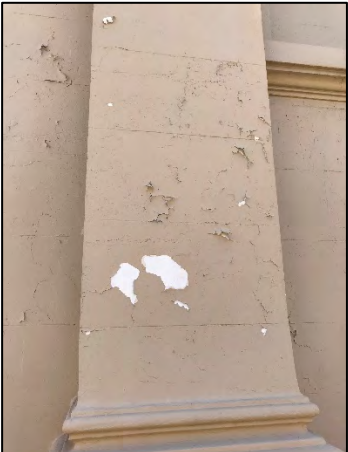
Closeup of peeling

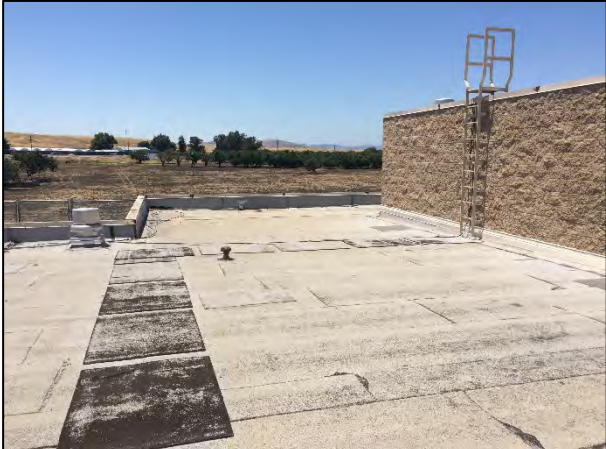
Roof at end of useful life

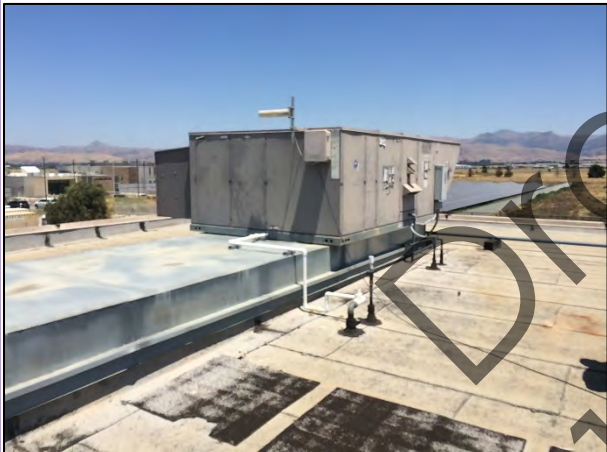
4. Elevators	NA	
5. Plumbing	Replace all staff/public fixtures, verify piping based on	\$ 135,247
6. HVAC	Replace large Roof Top Unit, clean/repair ductwork	\$ 557,816

Roof Top Unit at end of useful life

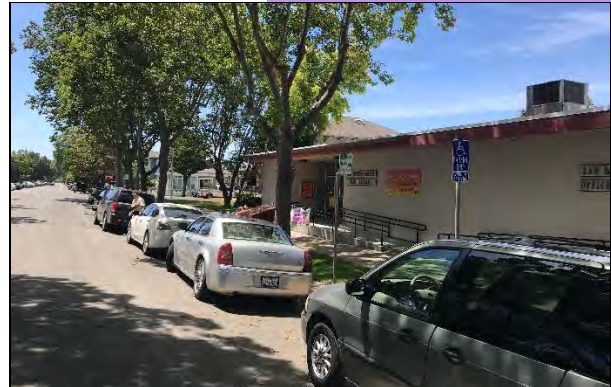
## Library/Office of Education

**Facility Summary Observations:** The Library houses all the operations of the County Library and the County Office of Education. The building is in poor condition and will require extensive modifications to most systems to be upgraded to modern standards. The building should be considered for replacement.

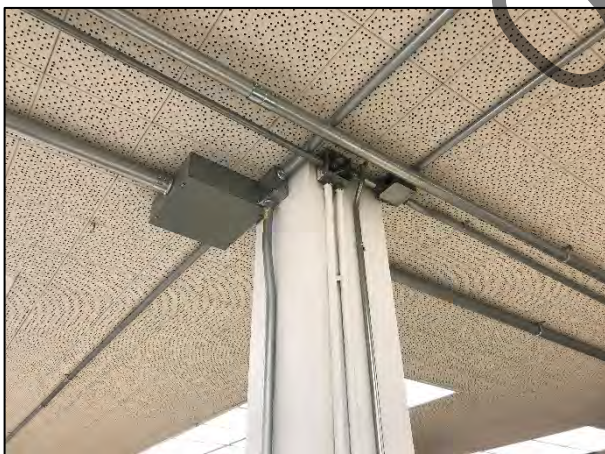
Exposed conduit in Reading Area

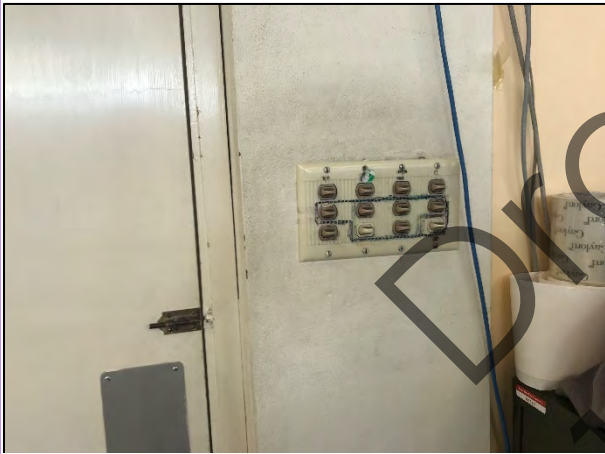
Outdated lighting controls

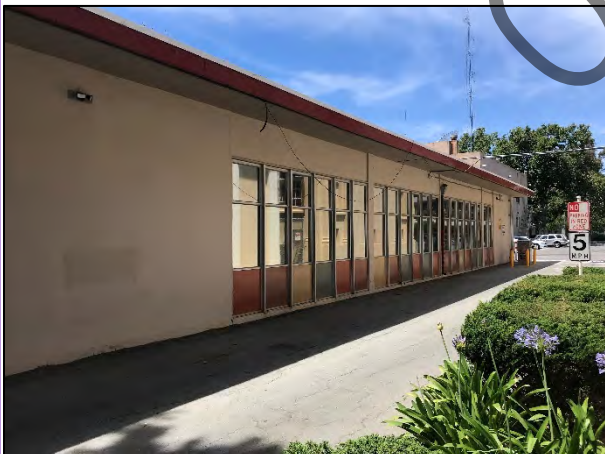
Exterior with outdated curtain wall system

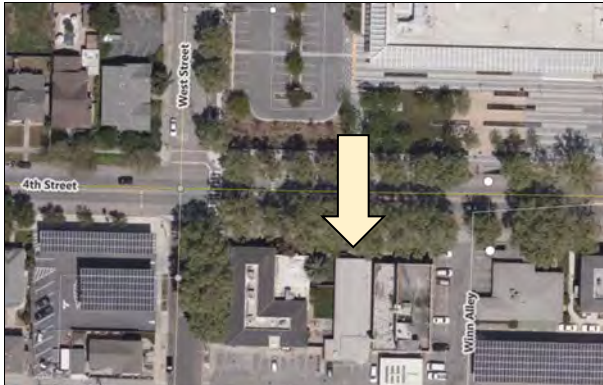
# Office of Emergency Services

**Facility Summary Observations:** The building houses all the operations of the Office of Emergency Services and also houses the County Network Operations Center 1 (NOC1). The building is in poor condition and will not be able to be upgraded to modern Essential Services facility standards reasonably. The building should be replaced.

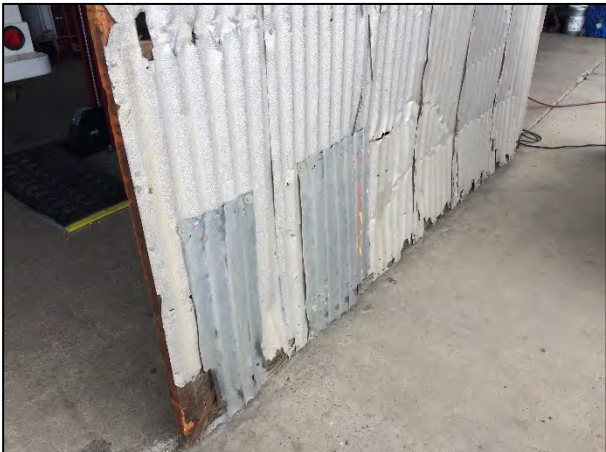
Truck Shop Exterior Siding

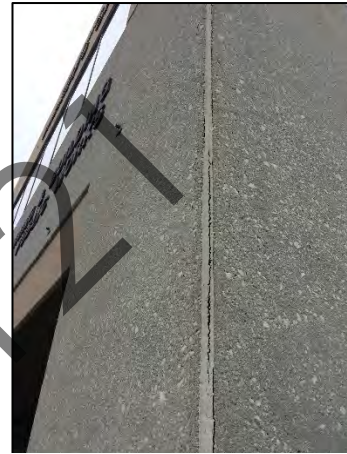
Failed joint sealant, typical
