Kleinfelder, Inc. *Natural Gas Pipeline Risk Analysis.* July 23, 2008.

**REPORT OF PHASE I
ENVIRONMENTAL SITE ASSESSMENT AND
LIMITED PHASE II SOIL TESTING
SANTANA RANCH
FAIRVIEW ROAD
HOLLISTER, CALIFORNIA**

Project: Santana Ranch
APNs 025-037-1,2,7,9 and 025-100-1
Fairview Road
Hollister, California

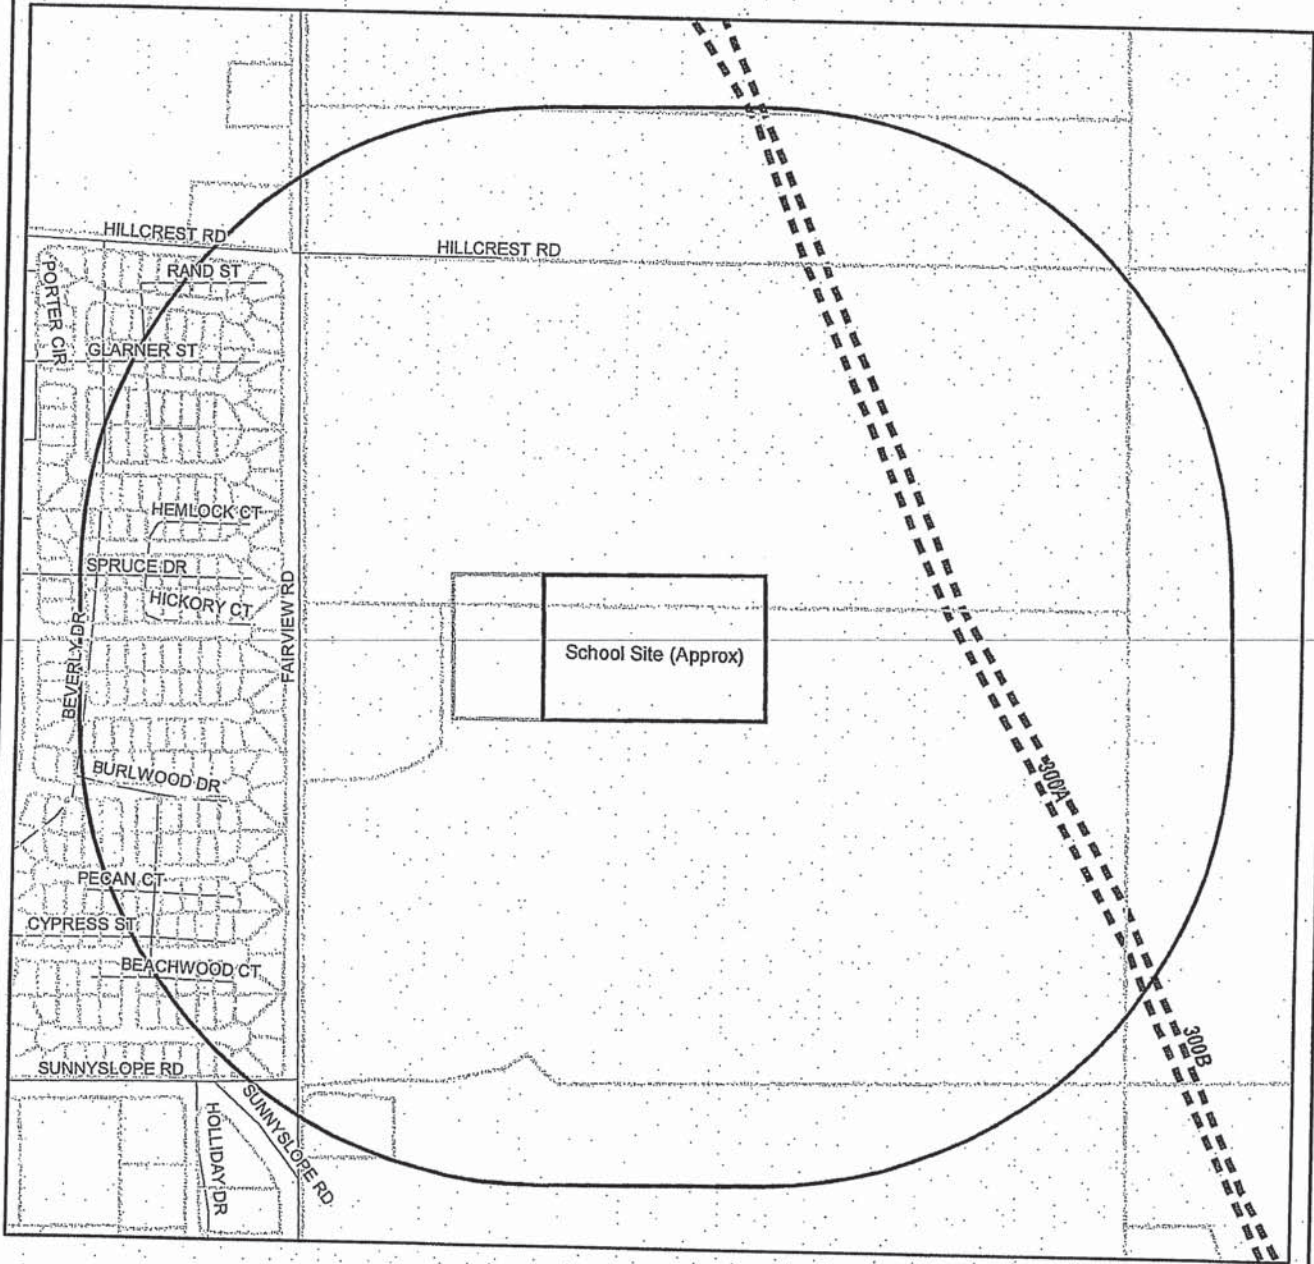
FIGURE 1

1500 ft Buffer around Project Site
Near Hillcrest and Fairview Roads, Hollister CA

Gas Transmission

--- Lines 300A, 300B

Pacific Gas & Electric (PG&E) operates two natural gas pipelines (300A and 300B) located in an easement running diagonally east (NW to SE) of Fairview Road between Hillcrest Road and Sunnyslope Road and within approximately 512 to 550 feet of the boundary of the proposed new school site (Figure 1). Both pipelines are 34-inch (diameter) steel gas transmission pipelines operated at a pressure of 620 psi, and have maximum allowable pressures of 715 psi. The pipelines have manual shut-off valves located approximately 2.7 miles northwest (Sally Street at 4th Street) of the proposed site. The easement for the two natural gas lines is regularly patrolled by PG&E and monitored for visual signs of damage. A cathodic protection system is in place which provides corrosion protection to the line. For transmission line 300A built in 1950,

- Figure 1 – Gas Transmission Lines 300A, 300B Near Hillcrest and Fairview Roads, Hollister CA
- Attachment 1 – PG&E Questionnaire For Natural Gas Pipeline Risk Analysis Study
- Attachment 2 – CDOE Forms 1-3 for 34 inch Natural Gas Pipeline (300A)
- Attachment 3 – Protocol Output for 34-inch Natural Gas Pipeline (300A)
- Attachment 4 – CDOE Forms 1-3 for 34 inch Natural Gas Pipeline (300B)
- Attachment 5 – Protocol Output for 34-inch Natural Gas Pipeline (300B)
