## Section Two Functional Needs Assessments

# Functional Needs Assessment

# Section Three Facility Condition Assessments

# Facility Condition Assessments

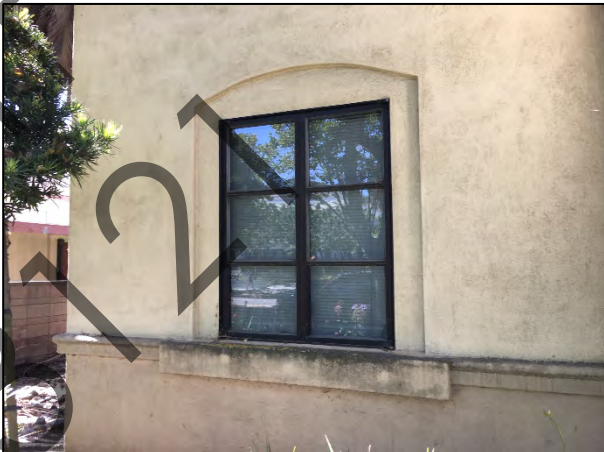
Window Detail

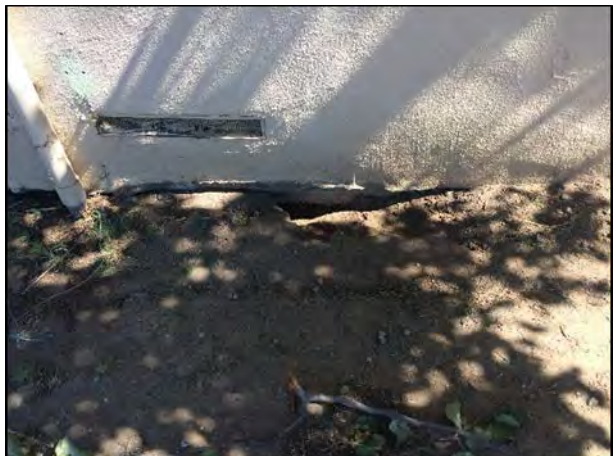
Exterior Animal Burrows

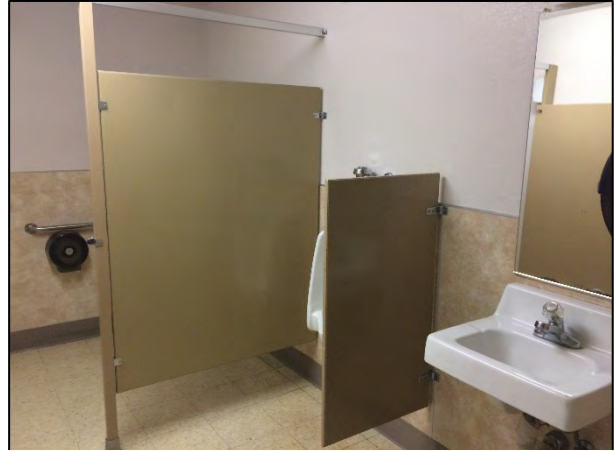
4. Elevators	NA	\$ -
5. Plumbing	All plumbing fixtures and fittings have exceeded useful life.	\$ -
6. HVAC	No issues noted	\$ -
7. Fire Protection	Verify location and number of devices	\$ -

Restroom

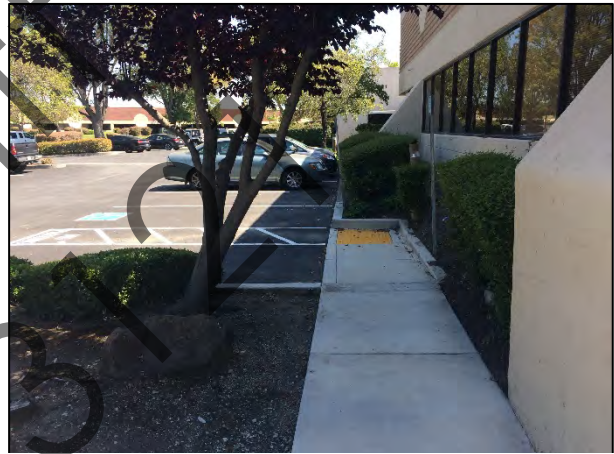
Newer accessible parking at entry

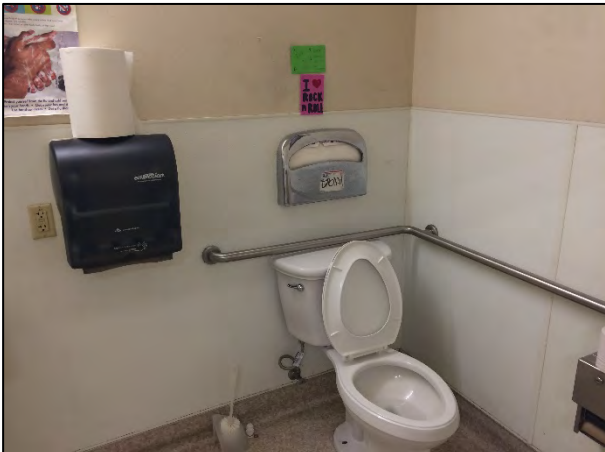
Restroom

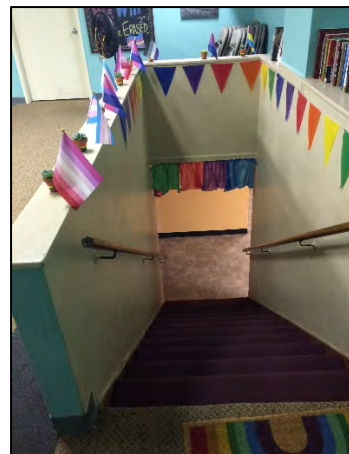
3. Interior Construction/Finishes	Replace doors at 2nd floor. Internal stair in poor condition.		\$ -
4. Elevators	None provided		\$ -
5. Plumbing	All plumbing fixtures past useful life. Restrooms have odor.		\$ -

Internal stair

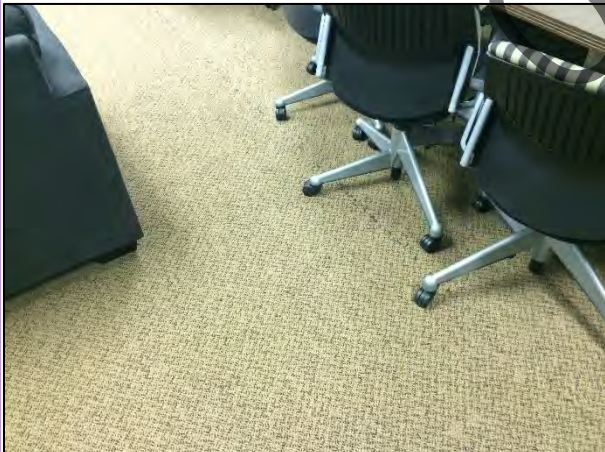
Damaged carpet

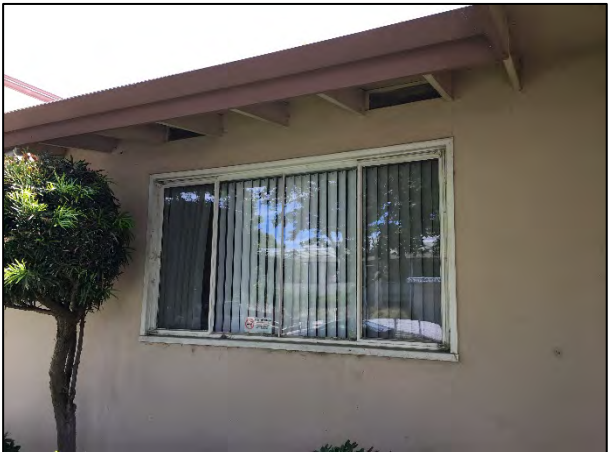
Single glazed window

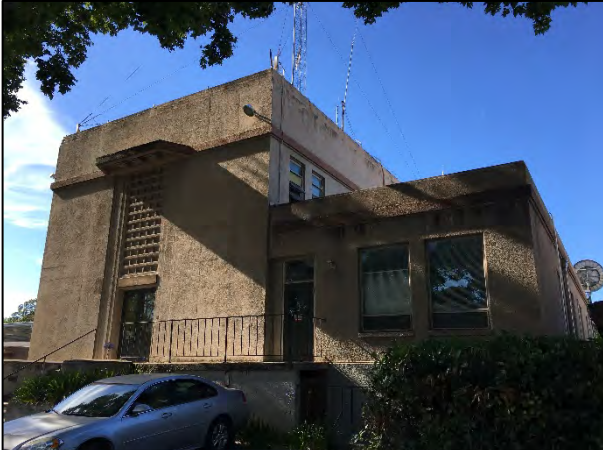
Front Entry

**Notes:**  
 First floor half level above grade. Many accessibility issues including front and back stairs to enter, no elevator, non-compliant stairs, insufficient number of exits.  
 Building in very poor condition

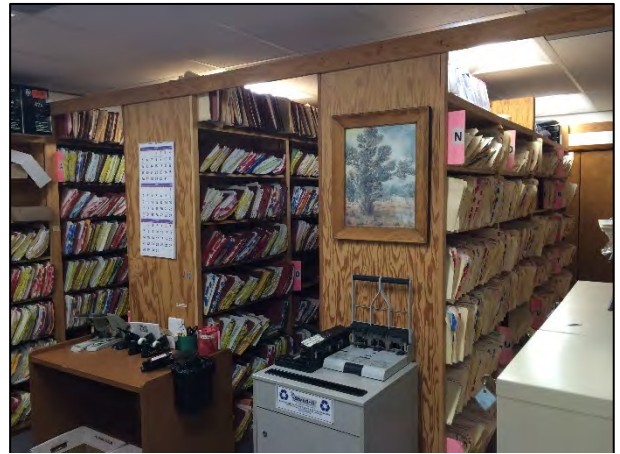
**Notes:**  
 Building is 25 years old and major systems such as electrical and plumbing are approaching the end of their normal life expectancy.  
 Numerous fire rated doors propped open  
 Stair in courtyard does not meet current code and should be replaced (nosings, railings, finish, width, etc.)

Stair with non-compliant handrail

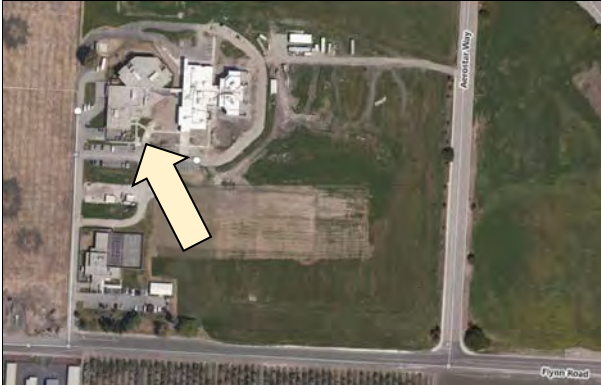
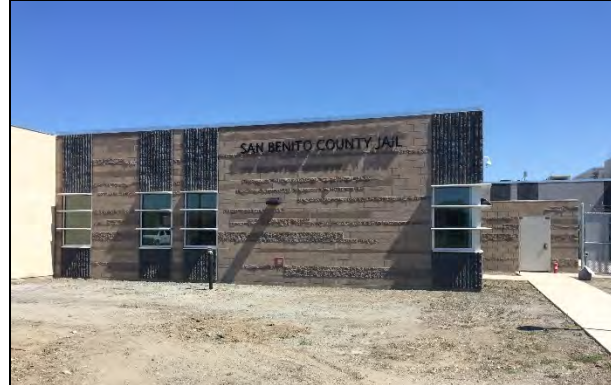
## Jail and Expansion

**Facility Summary Observations:** The Jail and Expansion are set back from Flynn Road, behind the Juvenile Facility. Since the Expansion was still completing construction at the time of this review no comments are made with the assumption that new construction should be in excellent condition. The Jail is in fair condition but upgrades to major systems such as plumbing, HVAC, and interior finishes will be necessary in the near future.

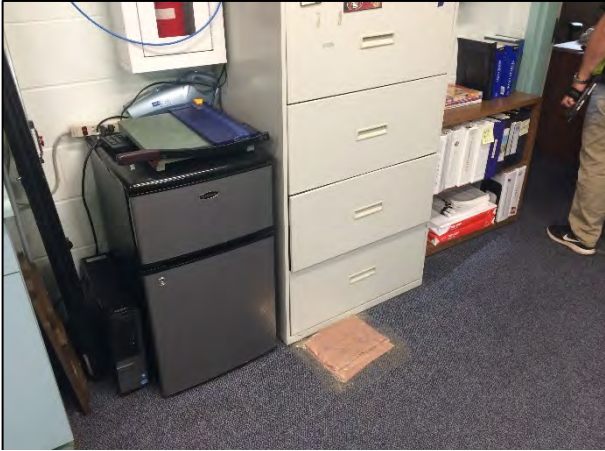
Jail Office – towel covers area that leaks

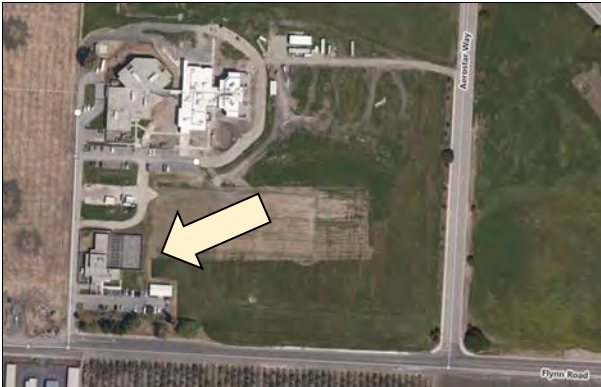
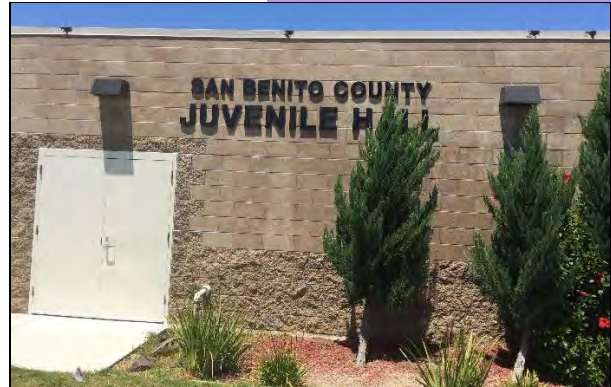
# Juvenile Hall

**Facility Summary Observations:** Juvenile Hall is adjacent to Flynn Road with the Jail and Expansion behind the Juvenile Facility. Juvenile Hall is in fair condition but upgrades to major systems such as plumbing, HVAC, and interior finishes will be necessary in the near future.

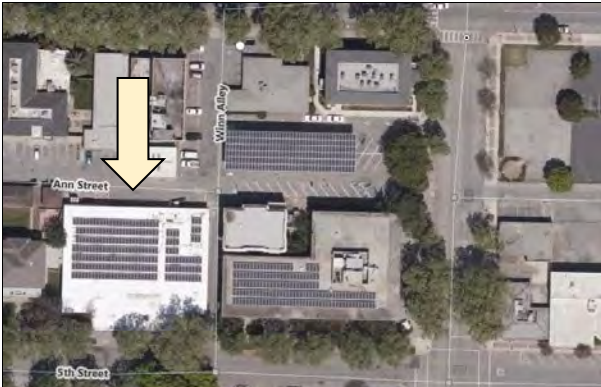
## Library/Office of Education

**Facility Summary Observations:** The Library houses all the operations of the County Library and the County Office of Education. The building is in poor condition and will require extensive modifications to most systems to be upgraded to modern standards. The building should be considered for replacement.

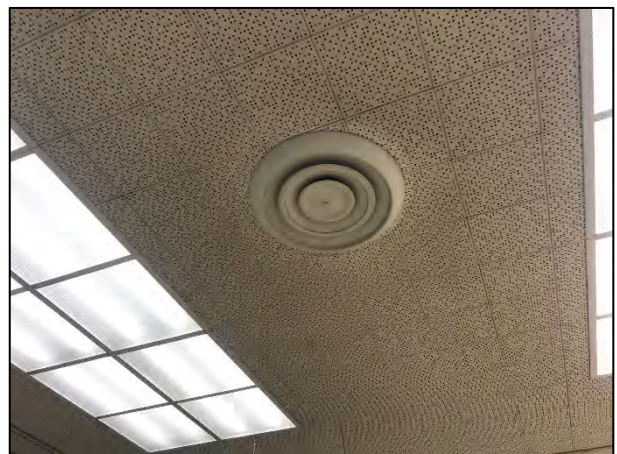
Outdated ceiling/diffuser

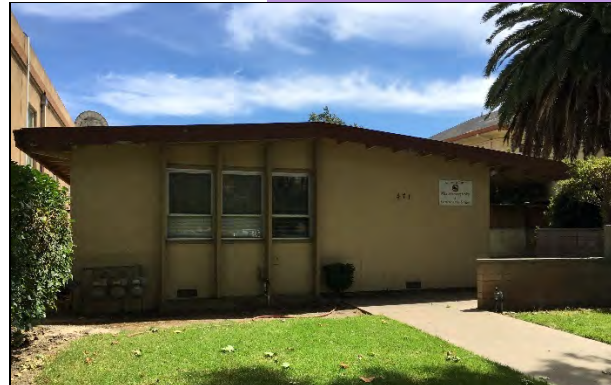
# Office of Emergency Services

**Facility Summary Observations:** The building houses all the operations of the Office of Emergency Services and also houses the County Network Operations Center 1 (NOC1). The building is in poor condition and will not be able to be upgraded to modern Essential Services facility standards reasonably. The building should be replaced.

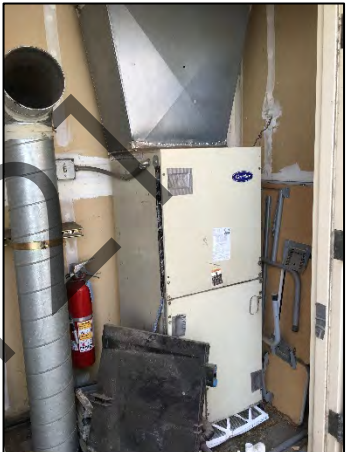
HVAC Unit

4. Elevators	NA		
5. Plumbing	Replace all staff/public fixtures, verify piping based on		\$ 50,780
6. HVAC	Replace complete system		\$ 418,880
7. Fire Protection	Provide fire protection systems		\$ 57,120

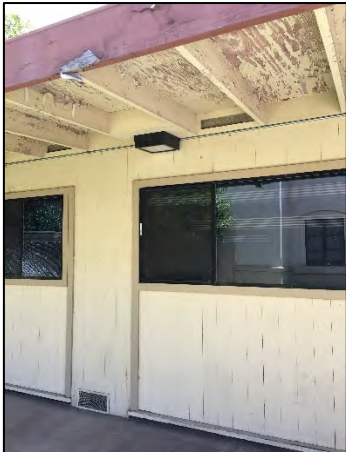
Exterior Wall

1. Substructure/Structure	No issues noted		\$ -
2. Exterior Envelope	Replace windows, doors, siding, and roof		\$ 218,816
3. Interior Construction/Finishes	Replace doors, new finishes throughout		\$ 99,825

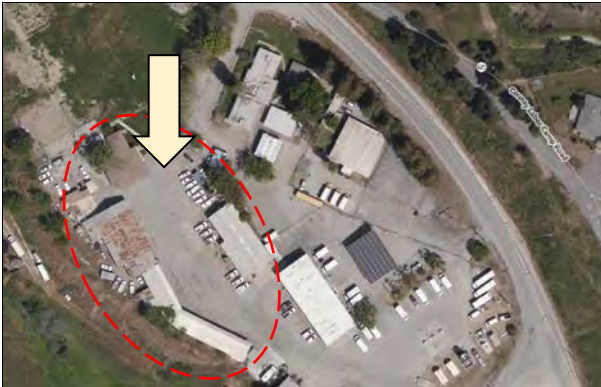
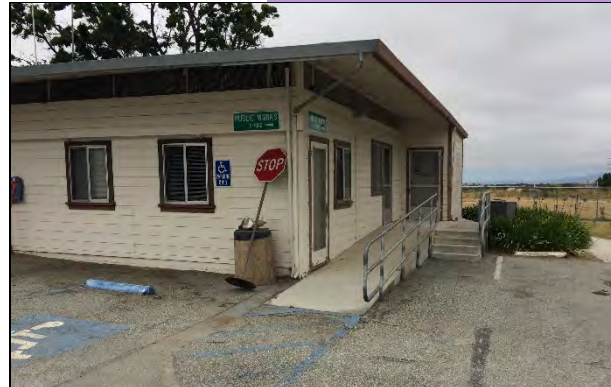
## Public Works Yard

**Facility Summary Observations:** The Public Works Yard consists of a series of buildings that house a range of services including offices, repair shops, materials storage, sign making, and equipment storage. The buildings are in poor condition and should be replaced.

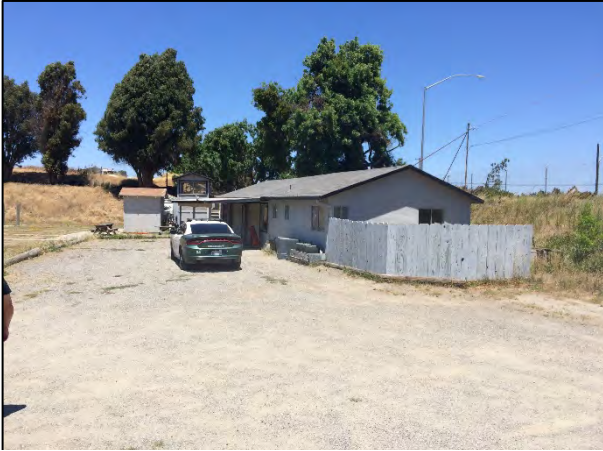
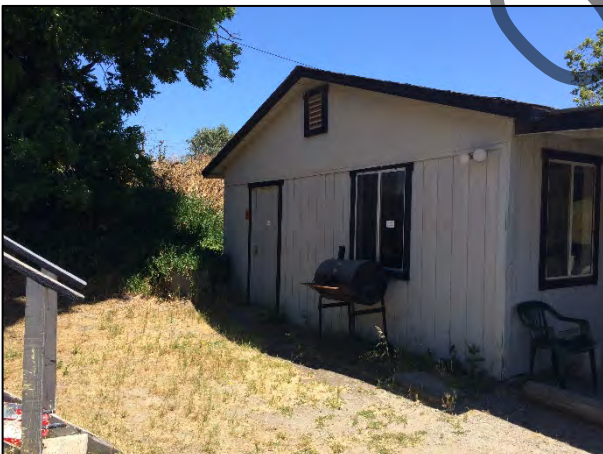
**Facility Summary Observations:** The site houses the Sheriff's Office Training Center; the building supports the outdoor shooting range immediately adjacent. The building is in very poor condition and will not be able to meet modern facility standards at a reasonable cost. The building should be replaced.

Exterior

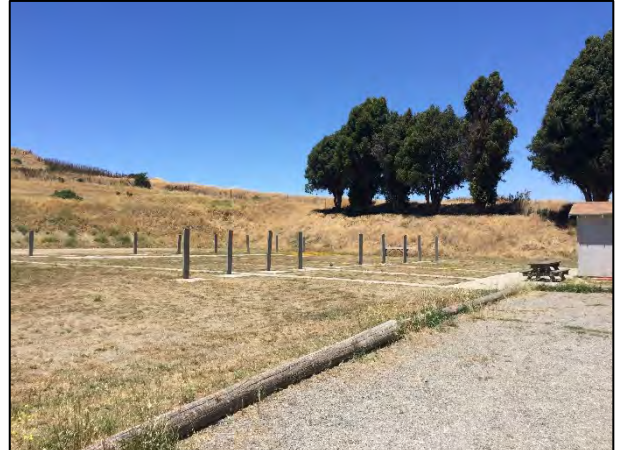
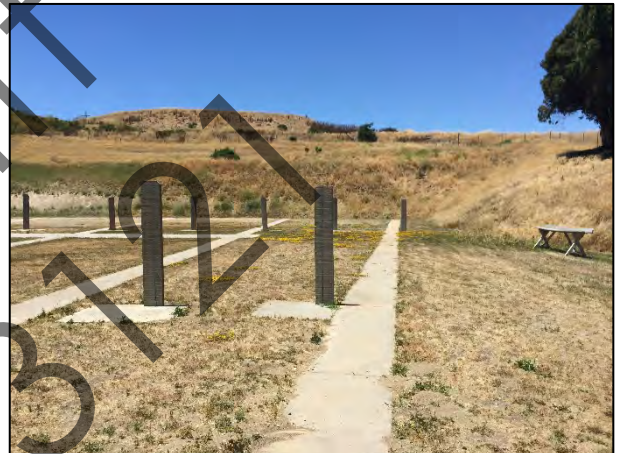
8. Electrical	Replace branch wiring/panels and lighting based on age		\$ 33,150
9. Equipment & Furnishings	None		\$ -
10. Site Improvements/Utilities	Add sidewalks, pave parking lot, upgrade shooting range		\$ 122,389
<b>DEFICIENCY TOTAL:</b>			<b>\$ 347,456</b>

Shooting Range

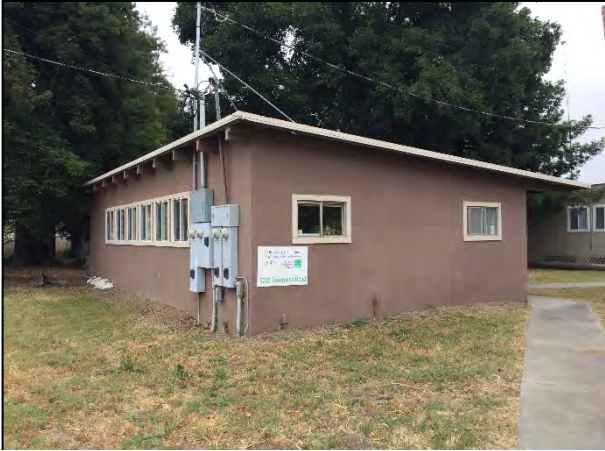
**Facility Summary Observations:** The building houses the University of California Cooperative Extension Office. The building is in very poor condition and will not be able to meet modern facility standards at a reasonable cost. The building should be replaced.

Exterior

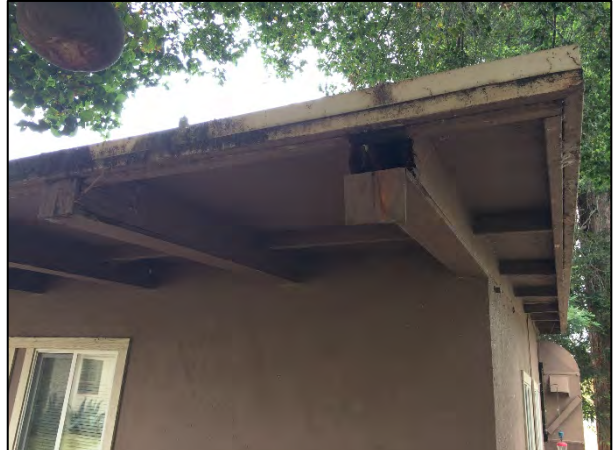
1. Substructure/Structure	Roof framing in poor condition	\$ 101,136
2. Exterior Envelope	Replace siding, windows, doors, and roof	\$ 118,424
3. Interior Construction/Finishes	New interior finishes throughout	\$ 162,077

Roof Overhang
